# Reconnaissance of the Effects of the $M_w5.7$ ( $M_L6.4$ ) Jajarkot Nepal Earthquake of 3 November 2023, Post-Earthquake Responses, and Associated Lessons to Be Learned

**Keywords:** 2023 Nepal earthquake; Jajarkot earthquake; earthquake damage survey; building damage; aftershocks; masonry structures

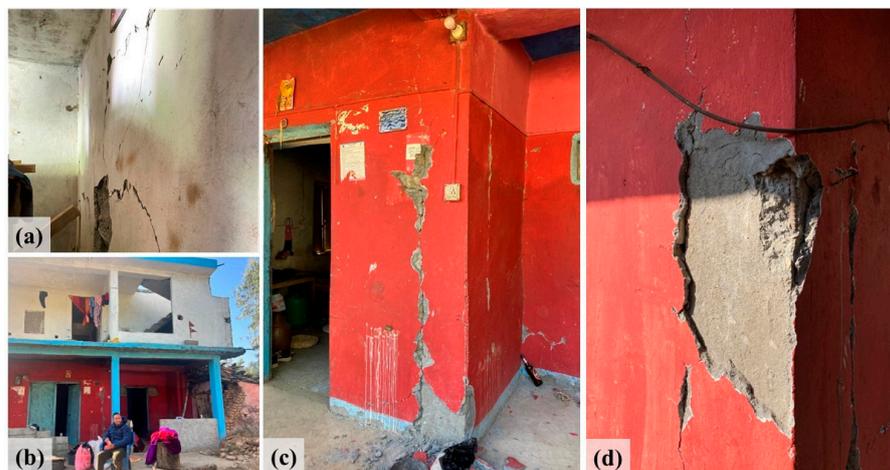
RC-framed buildings were found mostly undamaged during the earthquake, exhibiting only minor damage in most cases. The damage seen in a two-story RC-framed building in Raut Gaun is demonstrated in Figure 6. It was clear that poor quality concrete was used in the construction of these damaged buildings. Examples of low-strength concrete used in RC buildings are shown in Figure 6c,d. The concrete in these buildings was easily disintegrated by hand. The strength of the concrete materials appears to have been severely weakened using large-diameter aggregates. Furthermore, the aggregates seemed to be poorly or uniformly graded, resulting in a honeycomb pattern in the cast concrete and further reducing its strength.

**Figure 6.** Damage to RC frame building: (a) cracks in the walls; (b) front view of the two-story building; (c,d) separation of column from the masonry infills (28°41'55" N, 82°13'45" E).

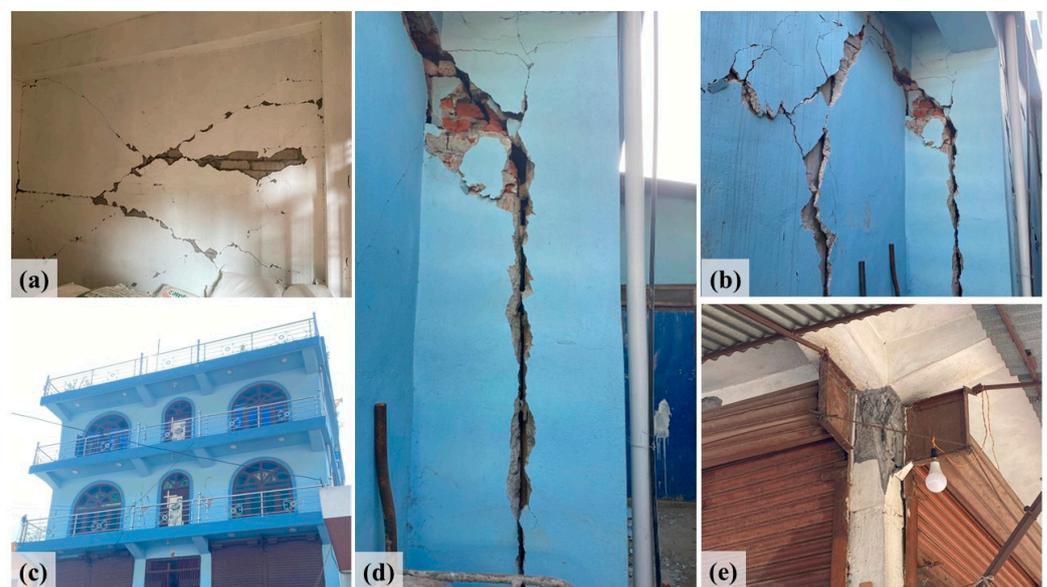
The four-story RC building located in Rimna Bazaar was damaged by the Jajarkot earthquake, as shown in Figure 7. Diagonal fissures on the brick infill wall of the building are depicted in Figure 7a. Furthermore, Figure 7b,d illustrate a poor connection by showing a noticeable space between the walls of the original structure and an attached expansion. These improper connections lead to the overall deformation of the main building because the extensions experience impact loads that cause severe damage. The strong beam and weak column connections are shown in Figure 7e. This type of connection is commonly found in RC buildings that have collapsed or sustained damage. Generally, when columns show weakness relative to beams, the overall ductility of the structure decreases. The weak column strong beam mechanism experiences a significant degradation in post-yield behavior, characterized by a significant loss of strength and limited displacement capacity. This emphasizes the vulnerability of buildings with strong beams and weak columns.

**Figure 7.** Damage to RC frame building: (a) diagonal cracks; (b) vertical and diagonal cracks; (c) four-story building with cracks in exterior walls; (d) separation of column from the wall; (e) joint failure in column (28°41'55" N, 82°16'46" E).

Further, the RC building with rolling shutters exhibited extensive damage attributed to column failure, as shown in Figure 7. During the installation of rolling shutters, the cover of RC columns is removed at specific locations along the column axis, revealing the primary reinforcement bars, which are then welded to the guide of the shutter. The introduction of rolling shutters markedly altered the stiffness and moment capacities of the RC columns by (1) diminishing the cross-sectional area of the column and (2) decreasing the strength and stiffness of the reinforcement bars due to overheating induced by the welding procedures. Similar observations were observed in the 2015 Gorkha earthquake in Nepal [7].

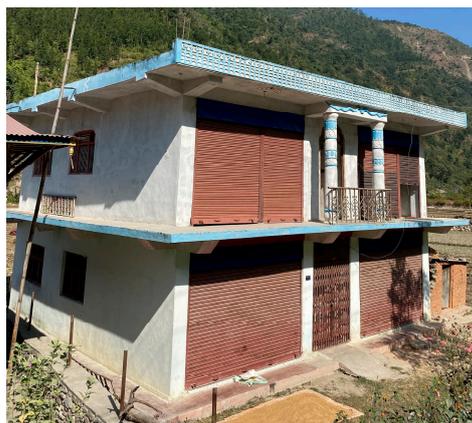
Nevertheless, the scale of damage sustained by RC buildings during the seismic event is comparatively limited when juxtaposed with their masonry counterparts. Despite the inadequate design and construction of most RC buildings in the region, they exhibited relatively good performance in this earthquake in comparison to masonry buildings, possibly due to the low peak ground acceleration (about 0.2 g) in the area. However, it is essential to dispel the misconception that RC buildings are inherently earthquake-resistant [32,33]. While reinforced concrete is a robust material, the earthquake resistance of a building relies on its proper design, following building codes, and the incorporation of seismic elements. Existing RC buildings (Figure 8) that do not adhere to the national building code should undergo retrofitting to ensure preparedness for future earthquakes.

**Figure 8.** RC-framed building in West Rukum with no adherence to building code guidelines.

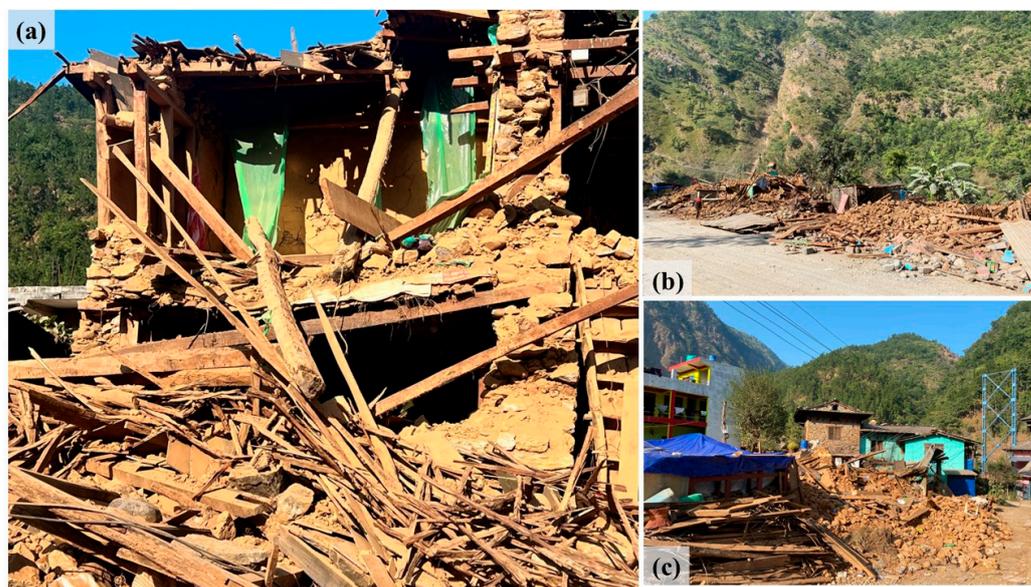
Masonry structures are commonly used as load-bearing structures. These structures transfer load through their walls and are constructed by combining individual units such as bricks, stones, marble, or limestone with mortar. While masonry structures are efficient during production, construction, and operation, they lack effectiveness in resisting earthquakes due to insufficient reinforcement. Their low tensile strength and high compressive strength, combined with a lack of ductility, make load-bearing structures prone to failure during seismic events. The severity of damage to unreinforced masonry buildings in Nepal is evident in Figure 9, which depicts residential structures reduced to rubble in various locations of Jajarkot district due to the earthquake.

**Figure 9.** (a) Close-up view of collapsed stone masonry building, (b), series of completely collapsed residential stone masonry buildings, and (c) collapsed and intact stones masonry building

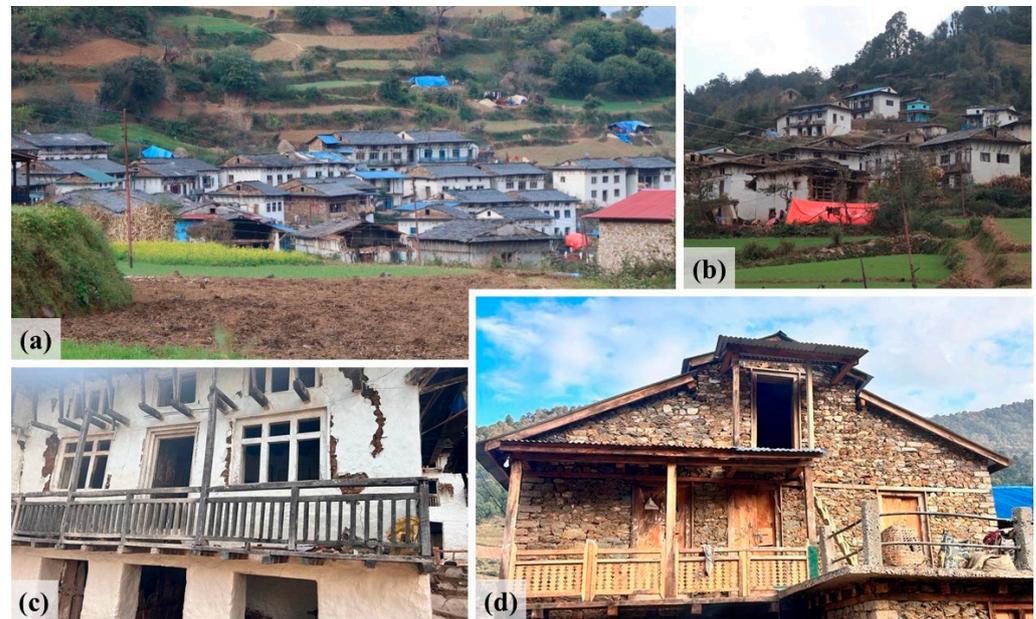
Some of the village's structures that were destroyed by the earthquake are shown in Figure 10b,c. In the post-earthquake observation (Figure 10d), the Sherpa village construction showed a heightened safety level compared to neighboring settlements.

**Figure 10.** (a,b) Sherpa Village near the epicenter (Ramidanda); (c) vertical and joint shear cracks; (d) undamaged building with wooden bands (28°55'11" N, 82°15'03" E).

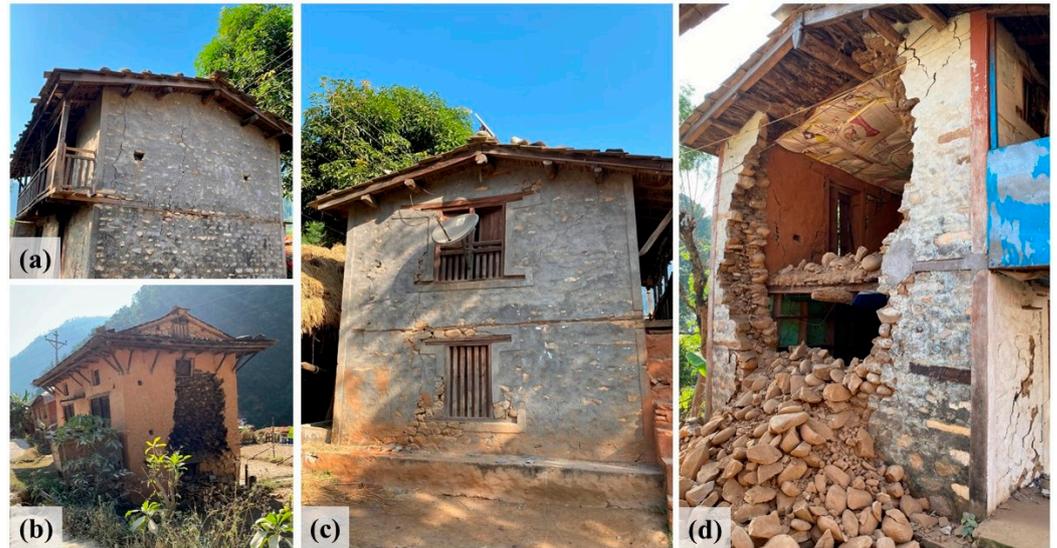
In general, buildings in the affected area had damage to their masonry walls, evident in the form of vertical or inclined shear cracks, as shown in Figure 11a,c. Figure 11b highlights the critical issue: the presence of cavities in the structural walls. These cavities seriously impair the capacity of walls to withstand flexural and shear stresses during seismic events, leading to damage. Additionally, when building thick walls, the use of small rubble rather than stones caused the wall to separate vertically. Figure 11d shows an out-of-plane failure in the load-bearing structure. This causes the failure of one face of the wall and occurs due to the insufficient bonding between the adjacent walls. When the seismic wave travels along the crest surface, the face perpendicular to the direction of the seismic wave cannot generate significant lateral force. This happens because the wall facing the wave has a reduced width, resulting in a low moment of resistance. It was observed that gable walls are highly susceptible to drift and out-of-plane lateral loads, primarily because they function as unsupported infill walls detached from the roof structures. A significant cause of damage to unreinforced masonry buildings is the collapse of these gable walls. The failure of gable walls can potentially lead to the subsequent failure of the shorter lateral walls. Considering their poor performance under such conditions, it is advisable to replace stone masonry gable walls with lighter materials, such as wooden planks or steel sheets, as a recommended measure. This substitution aims to enhance the overall structural resilience and mitigate the risk of gable wall failure in the face of lateral loads.

**Figure 11.** Damage in masonry buildings: (a) vertical cracks (28°41'52" N, 82°13'45" E) (b) vertical separation of wall (28°44'26" N, 82°17'27" E) (c) vertical cracks and damage at window (d) out of plane collapse of stone masonry wall (28°41'55" N, 82°13'46" E).

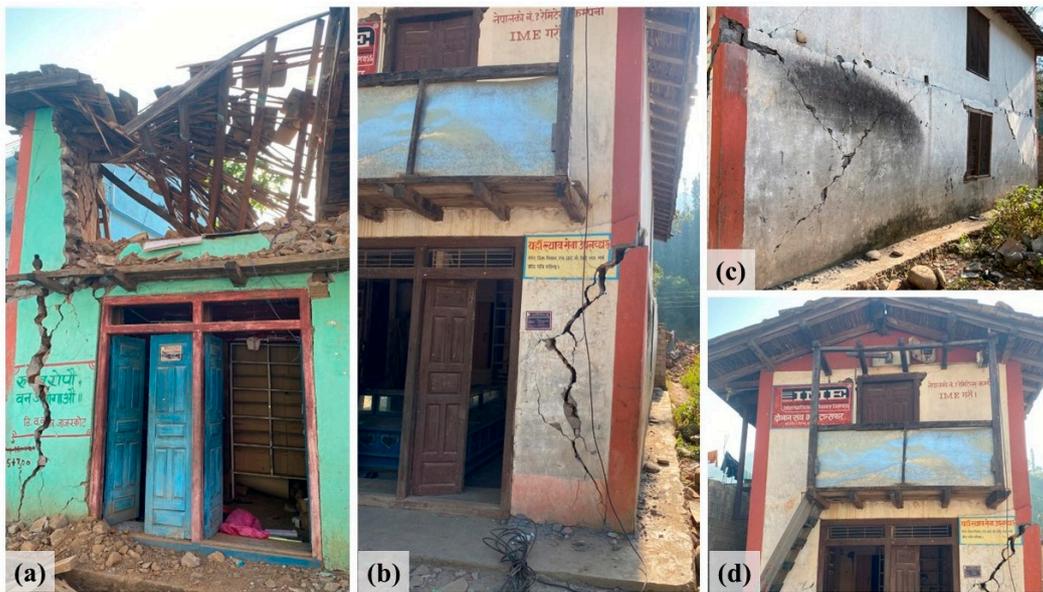
In Figure 12a, the failure of supporting walls and the collapse of the roof are recorded. Additionally, uneven foundation movement, inadequate connections between walls and floors, or out-of-plane bending brought on by seismic stresses perpendicular to the walls were also observed. Figure 12b illustrates observed failure and cracks at the corners, possibly stemming from these issues. The diagonal fractures in the masonry wall originating from the opening are shown in Figure 12c. The presence of apertures obstructs the load passage, leading to increased shear stress at lintel and sill levels, causing the formation of shear cracks. The poor connection between a stone masonry wall and the roof contributed significantly to structural failure during an earthquake. In seismic events, the dynamic forces exerted on a building can cause differential movement between the rigid stone masonry walls and the roof structure, especially if there is inadequate or improper anchoring and bracing. The lack of robust connections allowed for the independent movement of the wall and roof elements, leading to structural disintegration. The heavy mass of stone, combined with the brittle nature of the material, makes it particularly vulnerable to seismic forces. Without effective connections, the roof may have exerted additional stress on the stone masonry walls, leading to the development of cracks, separation at joints, or even the collapse of sections of the structure.

**Figure 12.** Damage in masonry buildings: (a) collapse of roof and failure of supporting walls of the building; (b) failure at the corner; (c) diagonal cracks; (d) vertical separation of masonry pier at corner ( $28^{\circ}41'57''$  N,  $82^{\circ}16'44''$  E).

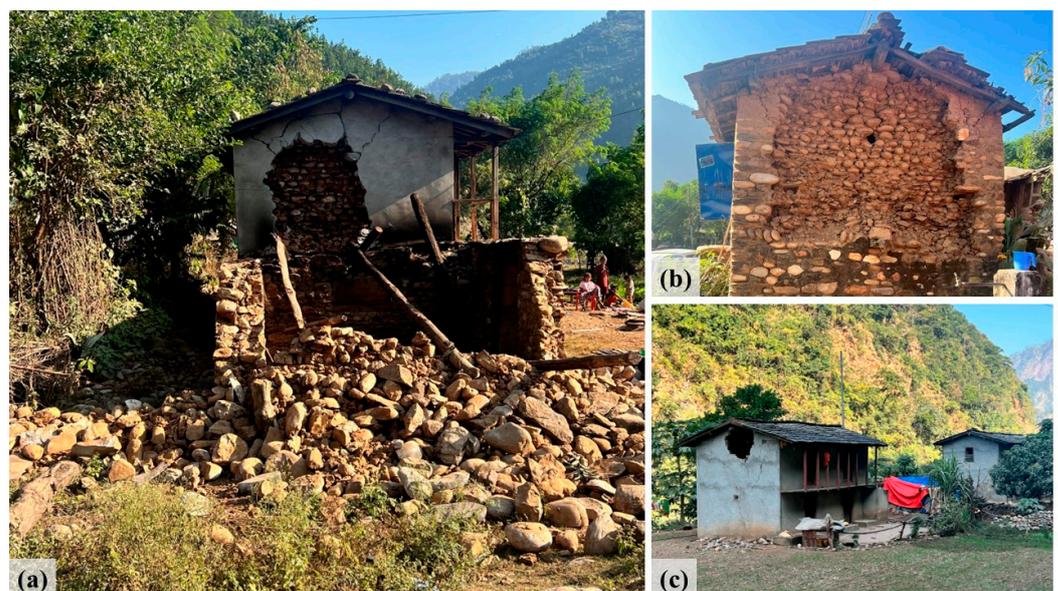
Additionally, Flexural out-of-plane failure is a major risk factor for unreinforced masonry structures, particularly in cases where there is a lack of proper wall-to-floor connection. This can lead to the collapse of entire wall panels or substantial sections when exposed to lateral seismic forces. The out-of-plane failure of load-bearing walls, caused by the failure of one wall face, is shown in Figure 13. This kind of collapse is made worse when there is inadequate bonding between neighboring walls, especially when seismic waves pass over the crest surface. The face perpendicular to the seismic wave experiences less lateral force due to its smaller breadth, resulting in a reduced moment of resistance. The disadvantages of employing rounded stone units are illustrated in Figure 13b, where it is shown how the smooth, rounded shapes of the units diminish bonding between them, allowing cracks to spread through weak mortar joints.

**Figure 13.** Damage in masonry buildings: out of plane collapse of stone masonry wall (a) ( $28^{\circ}41'56''$  N,  $82^{\circ}16'46''$  E) (b) ( $28^{\circ}41'54''$  N,  $82^{\circ}13'45''$  E) (c) ( $28^{\circ}42'42''$  N,  $82^{\circ}16'59''$  E).

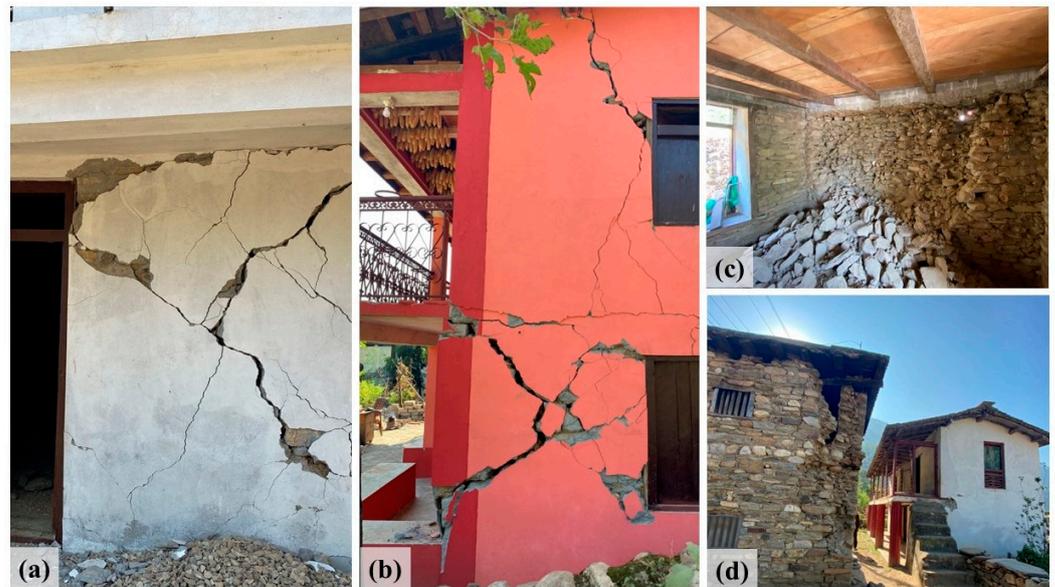
In stone masonry using cement mortar, shear damage frequently causes the separation of perpendicular walls, as shown in Figure 14a,b. This is particularly prevalent in cases where cornerstones are missing, which usually give some support. Figure 14c shows the out-of-plane failure of a stone masonry wall, and Figure 14d shows a failure between the walls due to inadequate bonding, which causes walls to separate from one another. A leading factor contributing to these sorts of connection failures is the insufficient number of connections.

**Figure 14.** Damage in masonry buildings: (a) wall pier diagonal cracking; (b) vertical and diagonal shear cracks in walls; (c) out of plane collapse of stone masonry wall ( $28^{\circ}41'58''$  N,  $82^{\circ}15'42''$  E); and (d) connection failure of the wall ( $28^{\circ}41'35''$  N,  $82^{\circ}14'03''$  E).

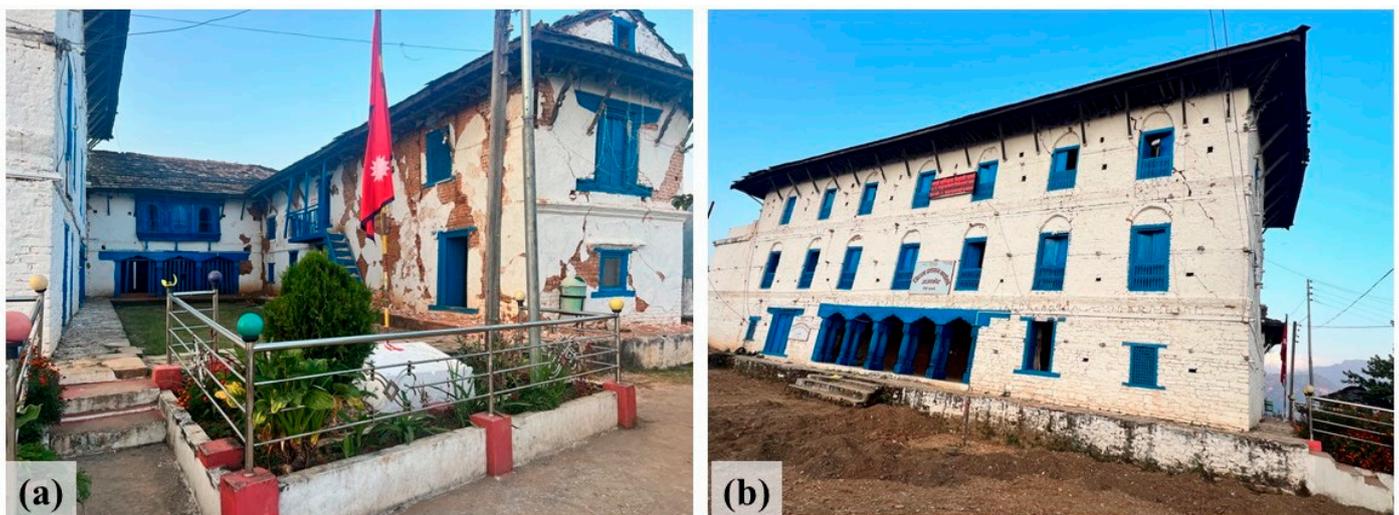
The Jajarkot Palace, an architectural and historical marvel constructed in 1825 B.S. by King of Jajarkot Hari Shah, suffered partial damage in the earthquake of 2023 (Figure 15). The minor damage could also be attributed to its recent retrofitting following the 2015 Gorkha earthquake. Popularly known as the ‘White Palace’, it holds immense cultural significance and is listed among the government’s designated tourist destinations. Unfortunately, the earthquake has not spared the nearby buildings of over a century in age, bearing historical value, as they too have incurred damage.

**Figure 15.** Damage to historical Jajarkot Palace, Khalanga, Jajarkot ( $28^{\circ}41'56''$  N,  $82^{\circ}12'01''$  E) (a) plaster spalling with several diagonal cracks and (b) cracks on the wall

Corner wall collapses were seen at the heritage site, with the torsional effect being the primary cause of damage. The presence of step-type shear cracks in unreinforced masonry (URM) walls not only contributed to the separation at corners but also posed a risk to the overall structural integrity. A noteworthy exception was seen in the district administration office in Jajarkot, where the installation of a timber band on the roof and lintels

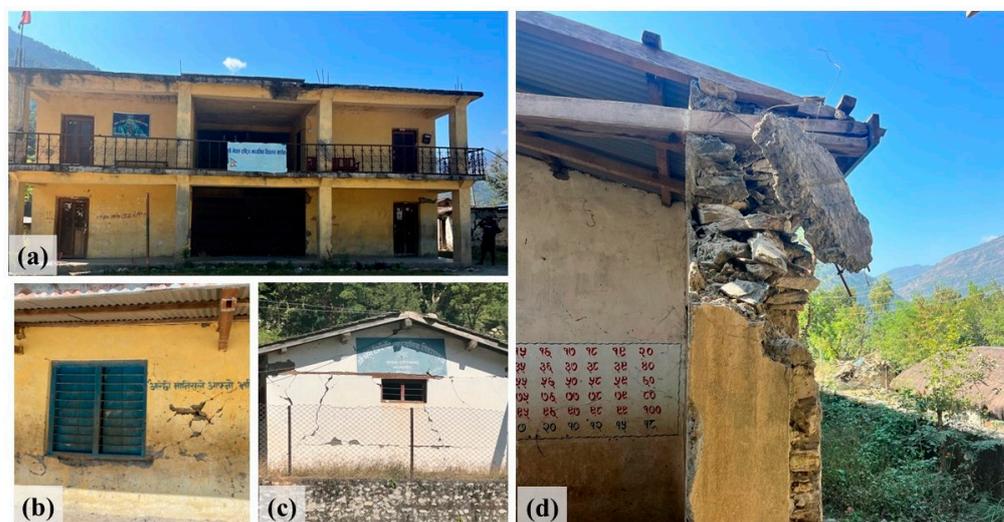
As of 20 November, the seismic event affected 898 school buildings; 294 sustained total damage, and 604 experienced partial damage. Additionally, 89 school toilets suffered partial damage due to the earthquake. This extensive destruction has directly impacted the education of 125,000 students [5]. An initial assessment carried out by the education cluster of Karnali Province identified that 65,867 students require urgent education assistance, including 5765 textbooks, to tackle the educational challenges brought up by the disaster. Figure 16 shows the damage suffered by the school infrastructure in Jajarkot and West Rukum districts due to the earthquake.

**Figure 16.** (a,b,c,d) Damage to school buildings of Jajarkot ( $28^{\circ}41'53''$  N,  $82^{\circ}16'20''$  E) and West Rukum ( $28^{\circ}47'06''$  N,  $82^{\circ}18'55''$  E).

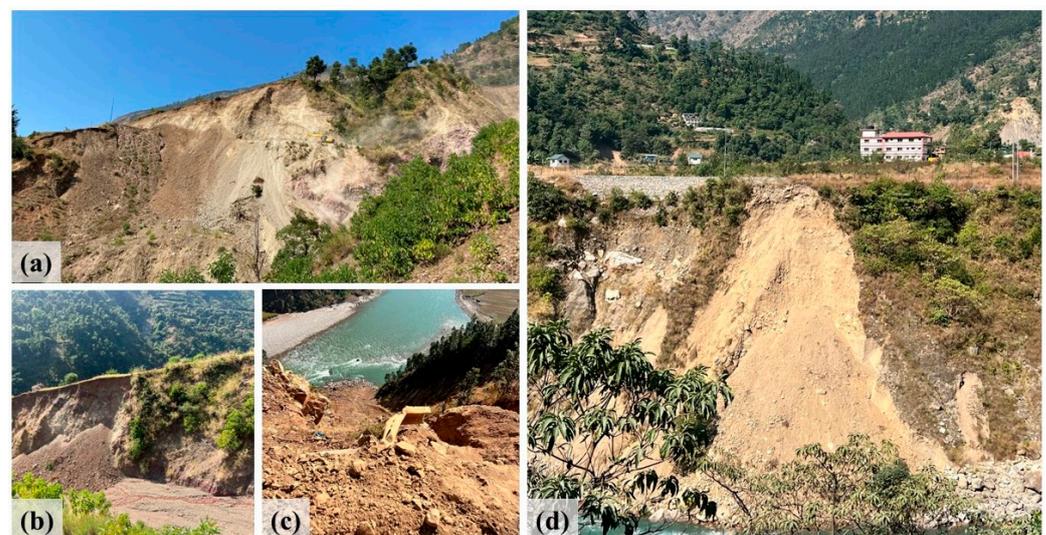
As shown in Figure 18a, a typical shallow landslide occurred on a steep slope near Nalgad Bazar. The debris was mostly composed of rocks, silt, and sand, as depicted in Figure 18b. Figure 18c shows the landslide that occurred along the lower section of the Midhill Highway close to China Bazar. An excavator was quickly mobilized to remove the obstruction caused by the landslide from the road. Furthermore, a shallow dry landslide near the Bheri Riverbank is seen in Figure 18d.

**Figure 18.** (a,b) Roadside shallow landslide along Bheri Corridor near Nalgad Bazaar (28°48'07" N, 82°17'22" E) (c) Roadside landslide along Midhill Highway near China Bazaar (28°42'14" N, 82°15'31" E) (d) Shallow landslide on the Bheri riverbank (28°47'05" N, 82°17'58" E).

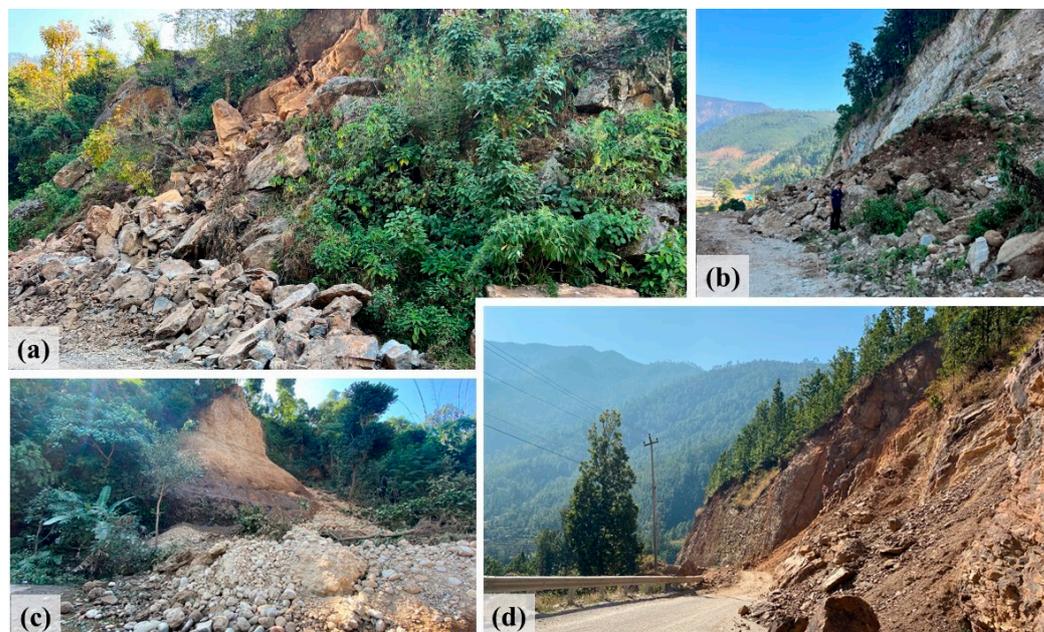
The earthquake-induced rockfalls on the road disrupted the smooth flow of traffic; however, temporary clearance of the road was undertaken during the survey period. In Figure 19a, an example of a weathered rock formation is depicted. Observations revealed rock masses of diverse sizes near the edge of the rockfall, suggesting the involvement of multiple rocks or the fragmentation of a primary boulder into smaller pieces as it descended the hill.

**Figure 19.** (a) Rockfall ( $28^{\circ}42'29''$  N,  $82^{\circ}14'17''$  E) (b) ( $28^{\circ}41'19''$  N,  $82^{\circ}13'52''$  E) (c) ( $28^{\circ}41'54''$  N,  $82^{\circ}15'46''$  E) (d) ( $28^{\circ}42'14''$  N,  $82^{\circ}15'31''$  E).

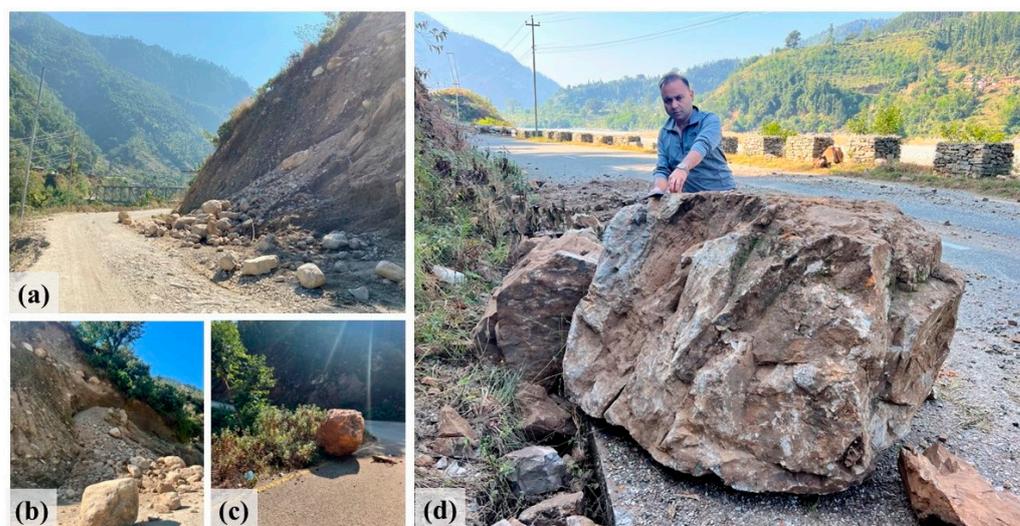
Rock falls were observed at various sections of the survey route, as shown in Figure 20. The rocks were of different sizes, varying from medium to large ( $0.5$  to  $5.8$  m<sup>3</sup>) in the Bheri Corridor, as seen in Figure 20b. Along the Midhill highway, notably larger rockfalls, reaching sizes up to  $1.73$  m<sup>3</sup>, were observed, as shown in Figure 20d.

**Figure 20.** (a) Road obstruction due to continuous rock fall ( $28^{\circ}46'51''$  N,  $82^{\circ}17'33''$  E) (b) medium to large size rockfall ( $28^{\circ}46'50''$  N,  $82^{\circ}17'33''$  E) along Bheri Corridor (c) rockfall ( $28^{\circ}42'22''$  N,  $82^{\circ}15'17''$  E) (d) large size rocks fall up to  $1.73$  m<sup>3</sup> ( $28^{\circ}42'17''$  N,  $82^{\circ}14'08''$  E) along Midhill Highway.

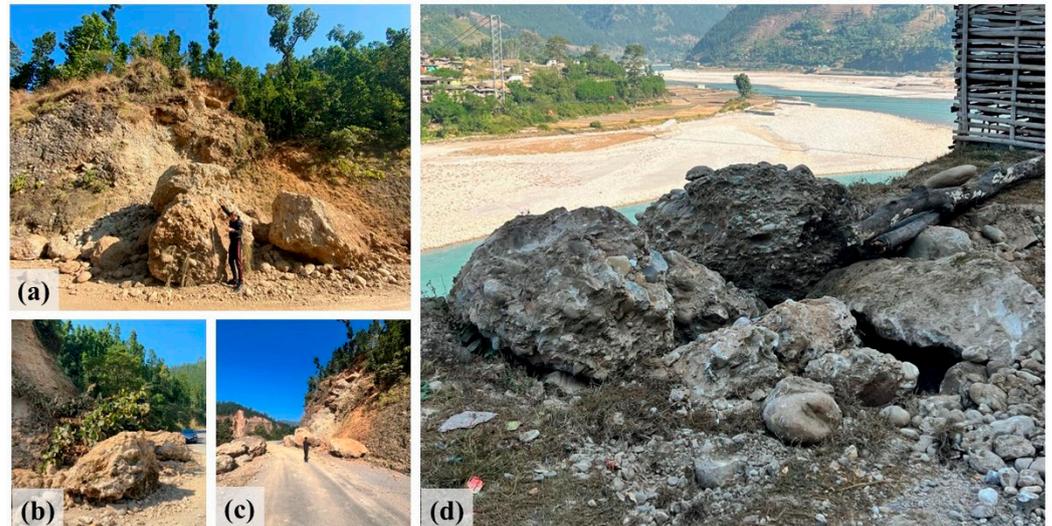
Substantial rocks of considerable size were discovered along the Bheri Corridor, as indicated in Figure 21a,c. These rocks exhibit a maximum size of approx. 5.8 m<sup>3</sup>. Additionally, Figure 21b,d depict rocks found alongside the Midhill Highway.

**Figure 21.** Large size rocks fall along Bheri Corridor (a,c) maximum size of 5.8 m<sup>3</sup> (28°42′09″ N, 82°15′45″ E) and Midhill Highway (b) (28°41′59″ N, 82°15′39″ E) (d) (28°41′12″ N, 82°13′39″ E).

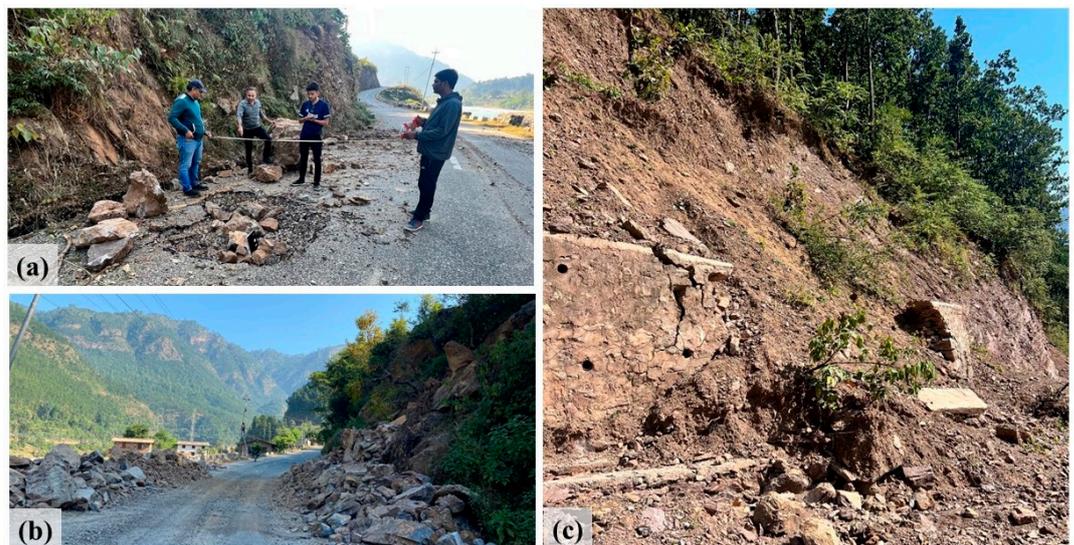
These rockfalls caused substantial damage to the road infrastructure, as depicted in Figure 22, leading to the formation of a large pothole in the pavement, measuring up to 1.8 × 2.3 m, as illustrated in Figure 22a. The resultant road blockage due to the rockfall along the Midhill highway is visible in Figure 22b. Additionally, Figure 22c showcases the collapse of retaining walls on a local road at Nalgad Bazaar along the roadside slope.

**Figure 22.** Damage in road infrastructure: (a) rockfall caused large size pothole in pavement, with maximum size up to 1.8 × 2.3 m (28°42′17″ N, 82°14′08″ E) (b) road blockage due to rock fall (28°42′29″ N, 82°14′17″ E) along Midhill Highway (c) failure of roadside slope retaining wall (28°48′05″ N, 82°17′25″ E) along local road nearby Nalgad Bazaar.

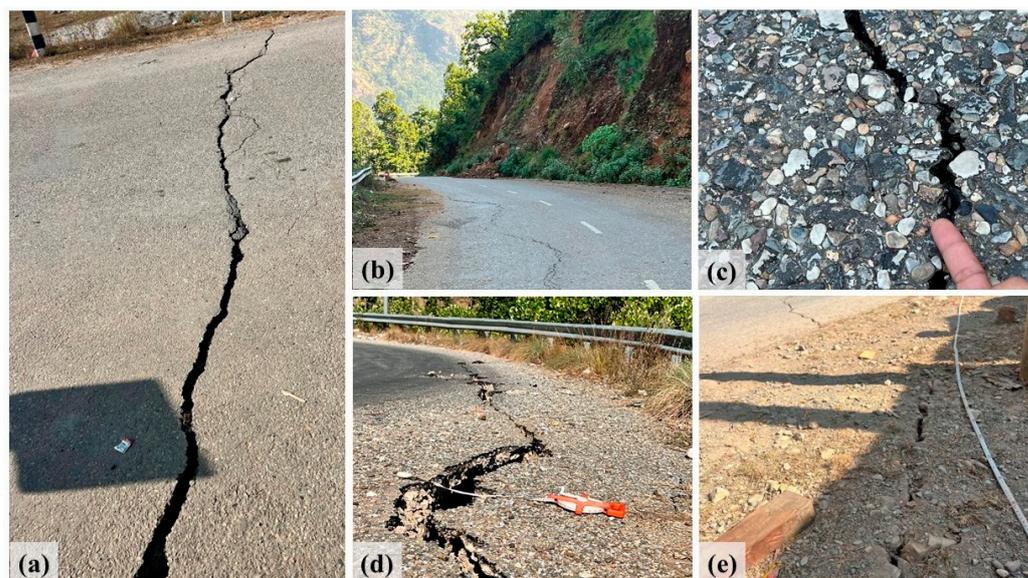
The earthquake inflicted structural damage on the road pavement, as illustrated in Figure 23. Figure 23a reveals a large transverse crack spanning the entire road, indicative of lateral ground movement during the seismic event. This type of cracking results from horizontal movement in the Earth's crust, causing the pavement to fracture perpendicular

to the road. Furthermore, Figure 23b displays longitudinal cracks with a maximum length of 120 m, suggesting shearing force or horizontal ground movement along the road during the earthquake.

The edge fracture and depression near China Bazaar, measuring 0.45 m in width and 1.82 m in depth, are shown in Figure 23d. This specific damage is attributed to the downslope slip phenomenon, in which seismic pressures weaken and fracture the pavement material at the margins, resulting in a sizable dip and edge crack. Figure 23e shows a diagonal crack near the Rimna Bridge, emphasizing the complex interaction between compressive and shearing forces during the earthquake-induced ground displacement.

**Figure 23.** Road subsidence and pavement cracks along different sections of the highway: (a) transverse crack throughout the road (28°41'57" N, 82°16'45" E) (b) longitudinal cracks extending up to 120 m (28°42'21" N, 82°15'19" E) (c) transverse crack (28°42'13" N, 82°14'07" E) (d) edge crack and depression with maximum width 0.45 m and depth 1.82 m due to downslope slip nearby China Bazaar (28°42'01.6" N, 82°15'32" E) (e) diagonal crack nearby the Rimna Bridge (28°42'03" N, 82°16'46" E).

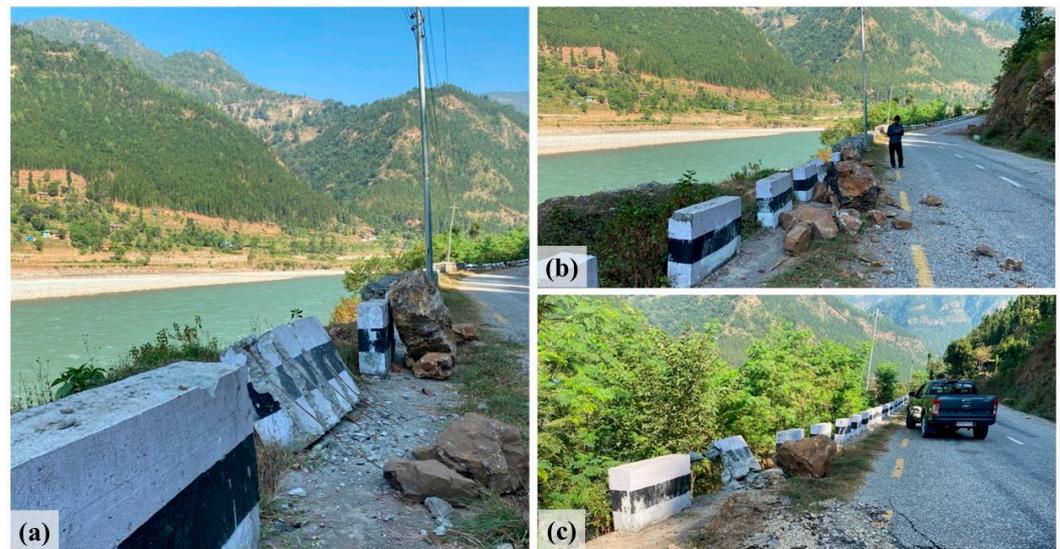
The impact of earthquake-induced rockfalls and landslides is apparent in various sections. Figure 24 illustrates the earthquake's effect on roadside concrete barriers along the Midhill highways in West Rukum. The 0.6 m high and 0.2 m wide concrete barrier suffered damage from falling boulders and debris, resulting in cracks, fractures, fissures, and dislodgments. This observed damage underscores the vulnerability of roadside infrastructure to seismic events, emphasizing the critical importance of targeted mitigation strategies and robust design in earthquake-prone areas like Nepal. More importantly, the study of KC et al. [36,37] highlights that the effect of earthquake preconditioning becomes apparent in the post-earthquake monsoon period, as evidenced by an increased rate of landslide disasters since the 2015 Gorkha earthquake. Thus, proper consideration of earthquake-affected vulnerable slopes is a must.

**Figure 24.** Damage to roadside concrete barriers in different sections along Midhill highway, West Rukum district (a,b) ( $28^{\circ}42'15''$  N,  $82^{\circ}14'07''$  E) (c) ( $28^{\circ}42'17''$  N,  $82^{\circ}14'08''$  E).

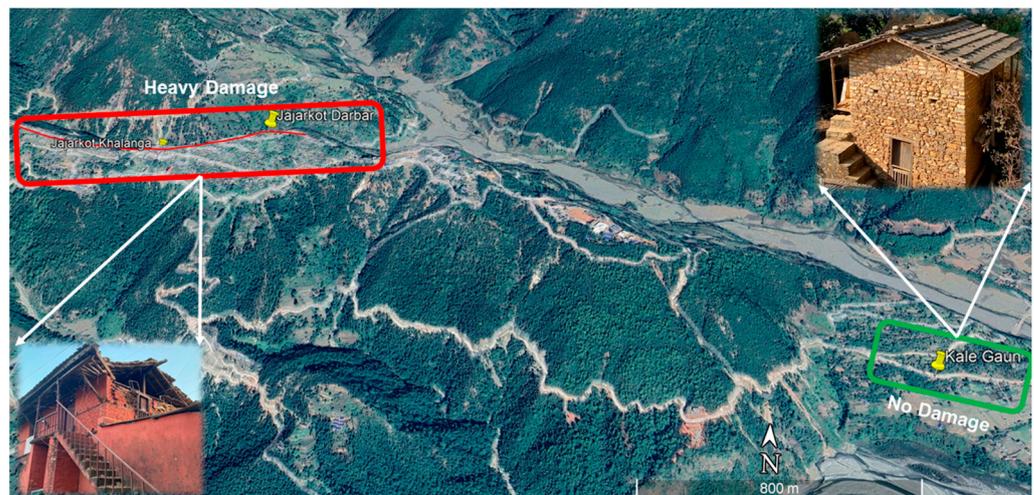
The terrain and soil of the area clearly had an impact on this earthquake. Figure 25 shows that the Jajarkot Khalanga ridge was the focal point of major infrastructure destruction, indicating the occurrence of topographic amplification. On the other hand, Kale Gaun, which is located on the hill's lower slope, sustained little damage from the earthquake. A similar ridge effect was noted at Barekot, Limsa. As seen in Figure 2, most of the damaged places that were inspected, including Raut Gaun, Rimna Bazaar, Radi Bazaar, and Nalgad Bazaar, were established on river deposits and were situated along the Bheri River corridor. The substantial damage in these regions further indicated the impact of the local soil characteristics. Thus, the localized ground effects observed align with findings reported by [38–40] in other earthquake studies (Pohang Earthquake, Sonitpur Earthquake). Sharma et al. [23] have also discussed the similar effects of surface geology and topography on the damage severity during the 2015 Gorkha Nepal Earthquake.

**Figure 25.** Damage in Khalanga, Jajarkot area indicating ridge effect due to earthquake.

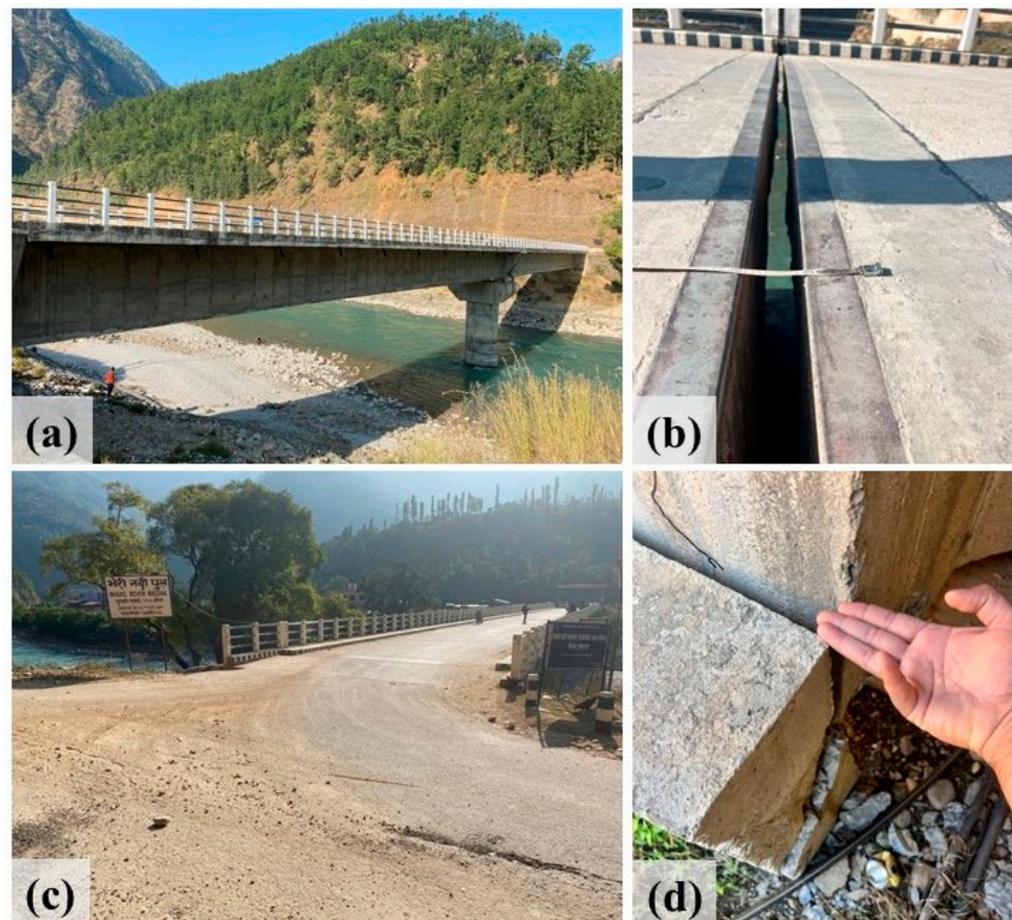
The reconnaissance visit revealed several observations about the bridge's condition. The bridge utilizes POT-PTFE fix-free bearing arrangements, and despite broken bolts at both abutments, the superstructure securely remains on the bearings. Notably, rotational movement at the expansion joint was observed, causing a significant increase in the gap at the center and a reduction at the end of the left span. Additionally, the stoppers on the upstream side were found to be broken diagonally at both abutments due to the impact of the superstructure. Despite these issues, the abutment, pier, and superstructure displayed minor damage, with no observed cracks in critical structural components. However, the approach road exhibited various cracks, particularly in the backfill of the abutments and the natural ground in the United Region. The inspection highlighted specific concerns, including broken bolts, rotational movement at the expansion joint, and damage to stoppers, emphasizing the immediate need for a bearing replacement plan followed by correcting the superstructure's dislocation.

**Figure 26.** (a) Partial damage in Bheri River bridge, Rimna ( $28^{\circ}42'03''$  N,  $82^{\circ}16'42''$  E) (b) displaced expansion joints, (c) cracks on approach road, and (d) damage to stoppers.
