# Seismic Performance of Buildings during the November 2023 Earthquake in Jajarkot, Nepal

Rajan KC<sup>1</sup>; Kabin Lamichhane, Aff.M.ASCE<sup>2</sup>; Keshab Sharma<sup>3</sup>; Mandip Subedi<sup>4</sup>; and Shikshita Bhandari<sup>5</sup>

**Author keywords:** 2023 Nepal Earthquake; Jajarkot Earthquake; Field reconnaissance; Structural damages; Masonry buildings; Reinforced concrete buildings.

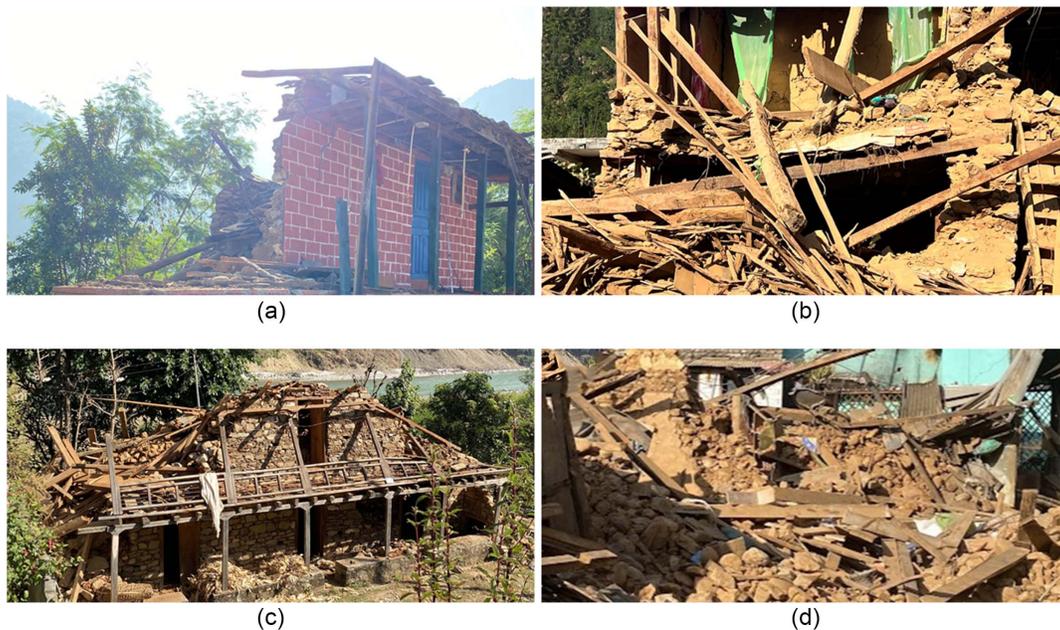
The prevalent construction style in the heavily impacted rural regions of Jajarkot was unreinforced stone masonry, which either completely collapsed or suffered extensive damage. A similar trend was observed during 2015 Gorkha Earthquake in Nepal (Acharya et al. 2023b; Parajuli et al. 2020; Khadka and Shakya 2021; Pan et al. 2018, 2024). Two of the districts most affected by the Jajarkot Earthquake, namely, Jajarkot and West Rukum, have 95.63% and 90.87%, respectively, of houses with mud-bonded brick/stone foundations. These structures are deficient in the ductile components essential for seismic resilience, leading to a tendency for brittle failure, which is a common issue in masonry buildings not reinforced with ductile materials. This section highlights the damage mechanisms in these types of structures in Western Nepal. Fig. 4 provides an overview of some masonry buildings nearer to the epicenter of the main shock in Jajarkot, Nepal, depicting overall devastation. The failure of these buildings can be attributed to several factors, including the weak bonding of walls made from boulders or rubble directly collected from riverbanks and held together with mud mortar or, in some cases, dry-stacked masonry units. Additionally, a lack of strong connections between floors and walls has also been observed in this case.

**Fig. 4.** Complete collapse of buildings during 2023 Jajarkot Earthquake in Nepal ( $28^{\circ}41'54''\text{N}$ ,  $82^{\circ}13'48''\text{E}$ ). (Images by Rajan KC.)

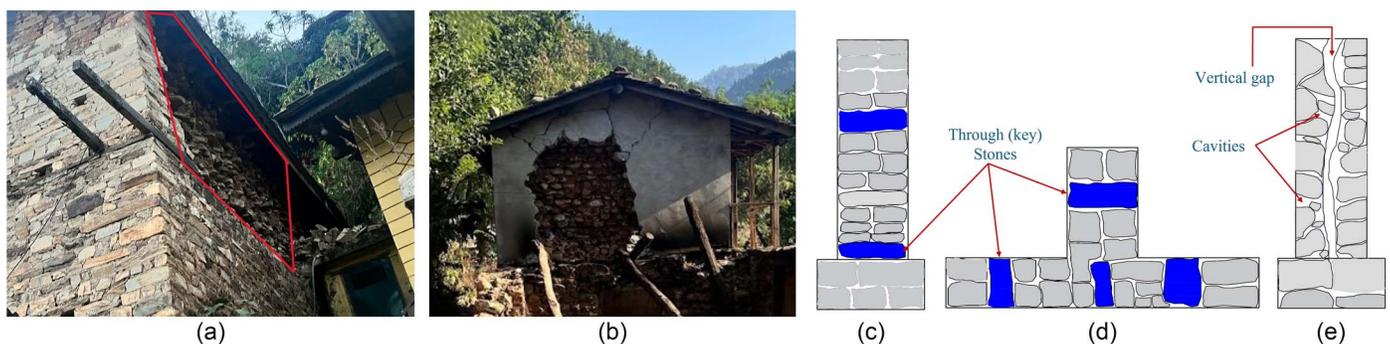
**Separation of the Wall.** The existence of voids within structural walls significantly hinders their ability to bear bending and shearing forces during earthquakes. Further, in the construction of thick walls, the absence of through-stones can lead to vertical separation in the wall. The utilization of ineffective mud mortars and inadequately integrated multileaf stone walls also resulted in the separation of wall layers, posing a potential risk of building collapse. Figs. 5(a and b) illustrate the vertical separation of the wall caused by the absence of through stones. Figs. 5(c–e) show the schematic wall section and plans with through (key) stones.

**Fig. 5.** (a and b) Separation of the wall along the vertical plane resulted from insufficient bonding between the inner and outside wall ( $28^{\circ}41'56''\text{N}$ ,  $82^{\circ}16'46''\text{E}$ ); (c) wall section including key stones; (d) wall plan including key stones; and (e) wall section without key stones. [Images (a and b) by Mandip Subedi.]

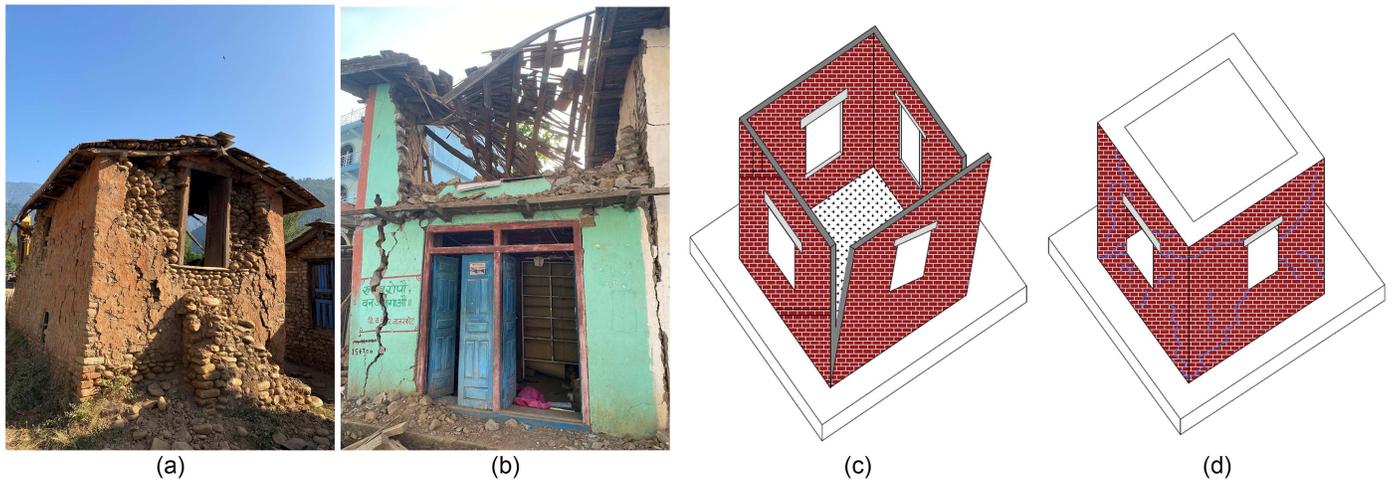
**Out-of-Plane Failure.** Fig. 6(a) shows the out-of-plane failure observed in a masonry structure, leading to the collapse of a single side of the wall; Fig. 6(b) shows the out-of-plane failure initiating the roof collapse. This failure is attributed to insufficient bonding between adjacent walls [as illustrated in Figs. 6(c and d)]. The phenomenon becomes noticeable when a seismic wave travels along the crest surface. The wall face perpendicular to the seismic wave direction does not produce substantial lateral force, primarily due to its lower width with a lower moment of resistance. Buildings

featuring extended facades, flexible floor structures, and inadequate connections between return walls often undergo partial or complete overturning or instability of load-bearing walls. This can result in moderate to severe damage and, in many cases, partial or full building collapse. Most buildings in Jajarkot experiencing out-of-plane failures had weak return wall connections, leading to separation and subsequent failure of entire walls. Additionally, almost all observed buildings had nonexistent connections between diaphragms and walls.

**Fig. 6.** (a) Out-of-plane failure of the masonry buildings made up of round-shaped stone (collected directly from the river); (b) out-of-plane failure initiating roof collapse ( $28^{\circ}41'57''$  N,  $82^{\circ}16'44''$  E); (c) schematic illustration showing out-of-plane failure; and (d) in-plane failure mechanism. [Images (a and b) by Rajan KC.]

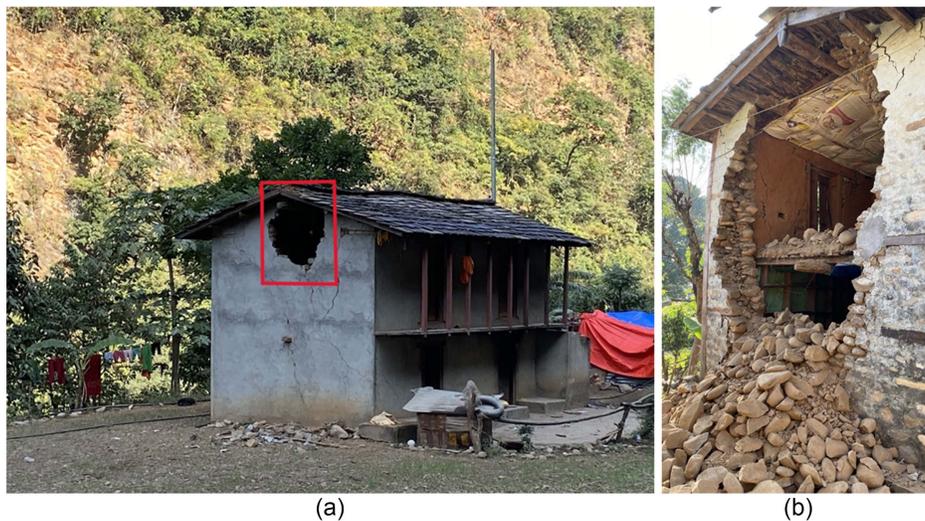
**Gable Wall Failure.** The failure of gable walls is illustrated in Fig. 7(a). The collapse of gable walls could potentially initiate the failure of the adjacent shorter lateral walls, as depicted in Fig. 7(b). The frequent out-of-plane failure of gables occurred because of inadequate connection between the gable and the roof. Constructing gables using lighter materials such as wood can effectively mitigate these failures, enhancing structural integrity.

**Fig. 7.** (a) Gable wall failure due to lack of gable band; and (b) gable wall failure initiating collapse of the shorter wall ( $28^{\circ}42'42''$  N,  $82^{\circ}16'59''$  E). (Images by Mandip Subedi.)

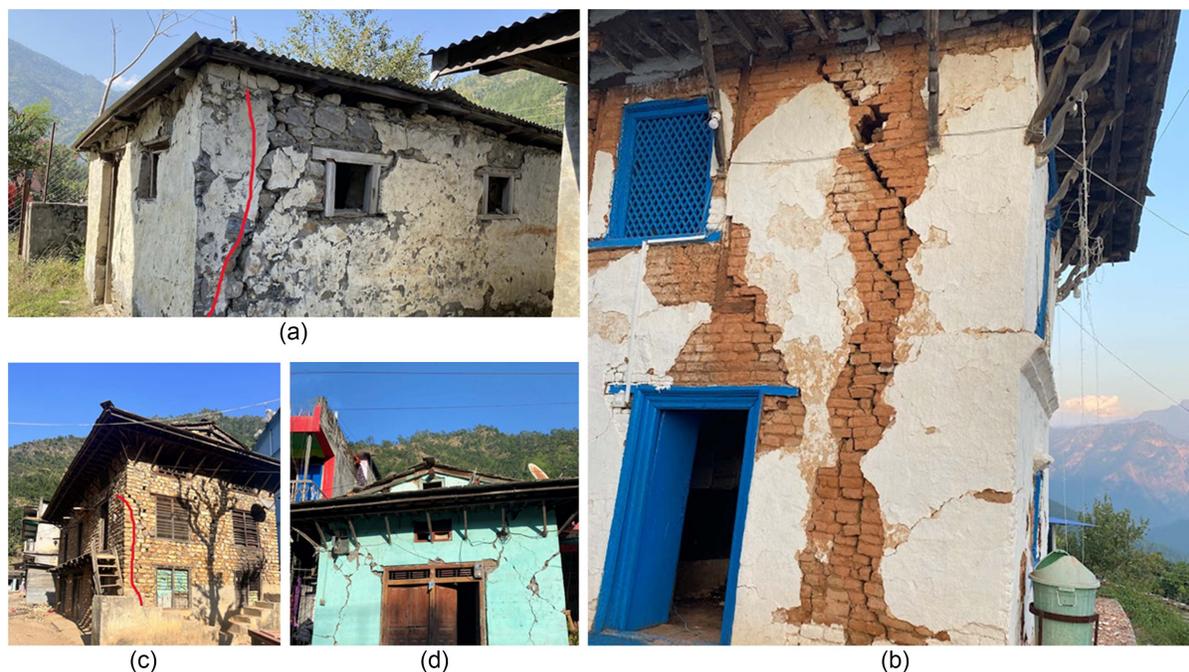
Additionally, out-of-plane bending, induced by earthquake loads perpendicular to the walls, could also be a factor triggering the formation of vertical cracks. Fig. 9 represents this type of failure, which was commonly observed in the village. This is also called “tensile failure.” The main reason for the failure is the lack of a reliable connection between the vertical walls and horizontal elements (roof, floor, beam, lintel). Masonry structures with mortar joints lacking ductile components fail to perform adequately during earthquakes due to their inability to absorb and dissipate the energy from lateral inertial forces generated by earthquakes, leading to brittle failure of the walls (Liu et al. 2021).

**Fig. 9.** Vertical shear crack: (a) masonry building; (b) Jajarkot palace; (c) three-story masonry building without bands; and (d) propagated at the wall of a building having both the opening at a shorter wall ( $28^{\circ}41'56''$  N,  $82^{\circ}12'01''$  E). (Images by Rajan KC.)

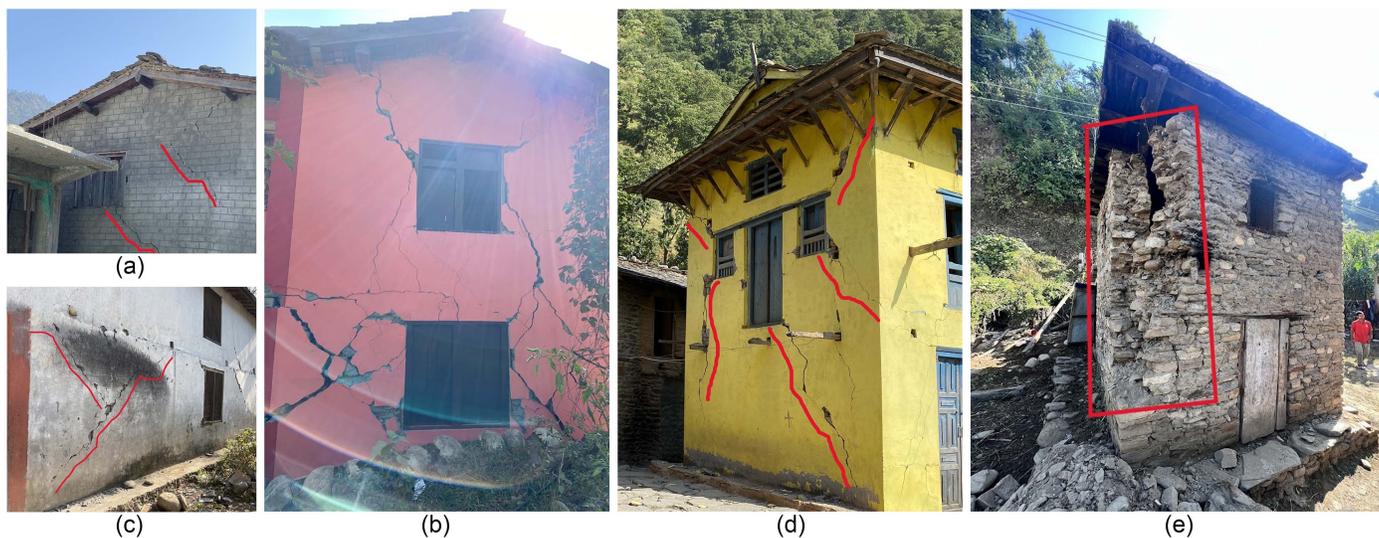
**Diagonal Shear Crack.** Openings such as doors or windows in masonry infill panels have the potential to reduce the lateral strength and stiffness of infill-frame systems. Figs. 10(a–d) illustrate diagonal shear cracks in the masonry wall. Among these, buildings in Figs. 10(a, b, and d) have cracks originating from openings.

The presence of openings hinders the transfer of loads, resulting in increased shear stress at lintel and sill levels, thereby causing the development of shear cracks. The expansion of openings within a wall contributes to a proportional increase in the stresses surrounding those specific openings (Shariq et al. 2008). Fig. 10(a) serves as a typical example of asymmetrically placed openings. This configuration consequently induced diagonal shear cracks. Fig. 10(c) depicts observed failures and cracks occurring at the corners, likely resulting from inadequate binding between the two lateral side walls and weak bonding in the corners.

**Connection Failure of Walls.** In Fig. 10(e), we can observe the failure between the walls attributed to inadequate bonding in the corner joint, resulting in their separation. Once this type of failure initiates, it will escalate the potential for collapse. An essential factor leading to these connection failures is the insufficient number of cornerstones. Other modern solution approaches include the use of proper reinforcement techniques like metal mesh or corner braces at the corners during construction.

**Fig. 10.** (a) Shear crack resulted from asymmetric arrangements of the window; (b) shear crack propagated throughout the wall ( $28^{\circ}41'58''$  N,  $82^{\circ}15'42''$  E); (c) diagonal shear crack at masonry wall; (d) shear crack originated from openings spreading throughout the wall ( $28^{\circ}41'57''$  N,  $82^{\circ}16'44''$  E); and (e) connection failure of walls due to lack of proper reinforcement and locking mechanism ( $28^{\circ}41'35''$  N,  $82^{\circ}14'03''$  E). (Images by Rajan KC.)

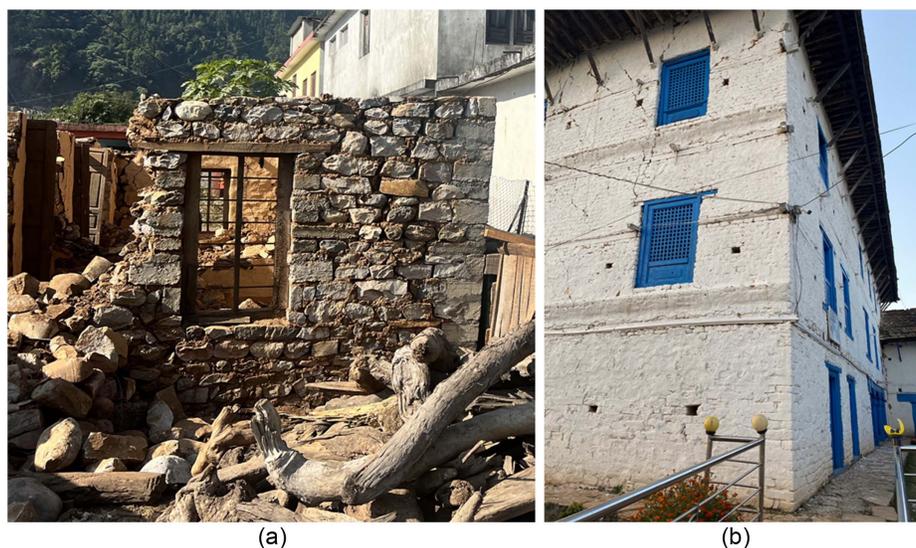
Even newly constructed buildings in Jajarkot, as depicted in Fig. 11(a), lack these essential bands, highlighting the lack of awareness and strict regulations. The presence of horizontal bands at different elevations in masonry walls helps resist the propagation of cracks and enhances bonding. However, the absence of these bands in Fig. 11(a) has led to the propagation of shear cracks in the corner, despite the wall being low in height, ultimately causing its collapse. On the other hand, in Fig. 11(b), the Jajarkot Palace, a remarkable architectural and historical monument having horizontal bands built 255 years ago, sustained only partial damage during the 2023 earthquake. The presence of bands has significantly contributed to its strength. Numerous historical monuments were destroyed during 2015 Gorkha Earthquake in Nepal as well, especially in Kathmandu Valley (Kawan et al. 2022). The use of wooden bands in its reconstruction has contributed to its increased safety. The incorporation of shear bands in masonry structures has been a longstanding practice in various countries for centuries and has demonstrated their effectiveness in improving the seismic performance of structures (Yadav et al. 2018). It is also promoted by the Government of Nepal in design manuals for rebuilding earthquake-resistant structures after the 2015 Gorkha Earthquake.

**Fig. 11.** (a) Newly built building without bands in Jajarkot; and (b) less affected Jajarkot Palace with wooden bands ( $28^{\circ}41'56''$  N,  $82^{\circ}12'01''$  E). (Images by Mandip Subedi.)

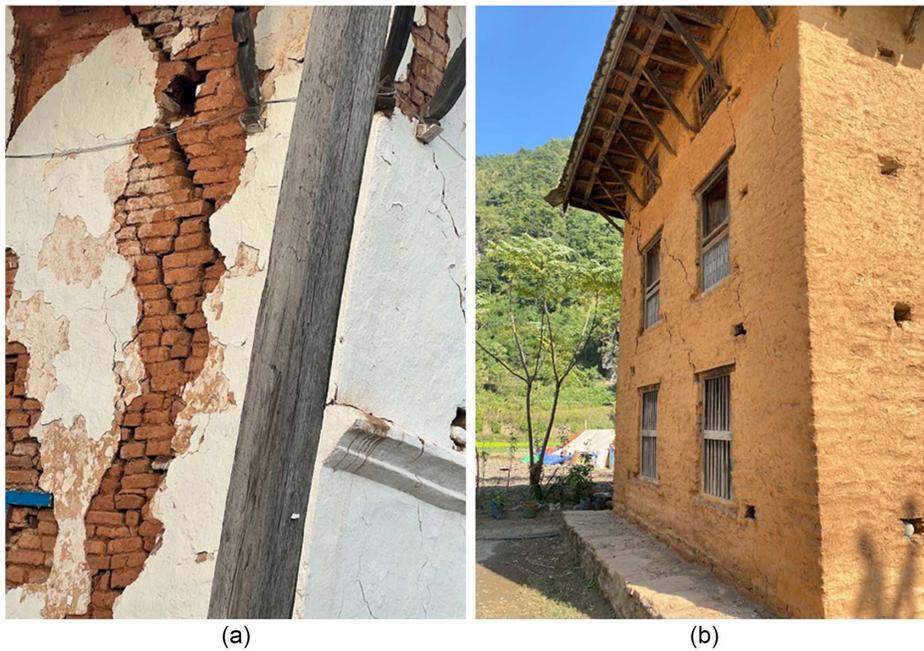
**Aging of Masonry Materials.** Many of the masonry structures in the Jajarkot area were constructed several generations ago, according to residents. These structures have never undergone strengthening or reconstruction since the occurrence of a major earthquake in Western Nepal centuries ago, specifically in 1505 AD. The mud mortar used in these buildings has deteriorated significantly, easily crumbling between one's fingers. This degradation serves as a clear indication that the mortar used in the buildings has aged to an extreme extent, including the Jajarkot Palace [Fig. 12(a)]. Similarly, field examinations have shown that many masonry buildings have walls made of randomly placed adobe bricks. Typically, they use mud mortar, lime, and cement as plaster materials. In these structures, the stress due to horizontal movement exceeds the decreased

strength of aging materials leading to cracks and more damage [Fig. 12(b)].

**Fig. 12.** (a) Extreme aged mortar resulting in lack of bonding between brick in Jajarkot Palace; and (b) aging of mortar resulted in cracks all around the building ( $28^{\circ}41'56''$  N,  $82^{\circ}12'01''$  E). (Images by Rajan KC.)

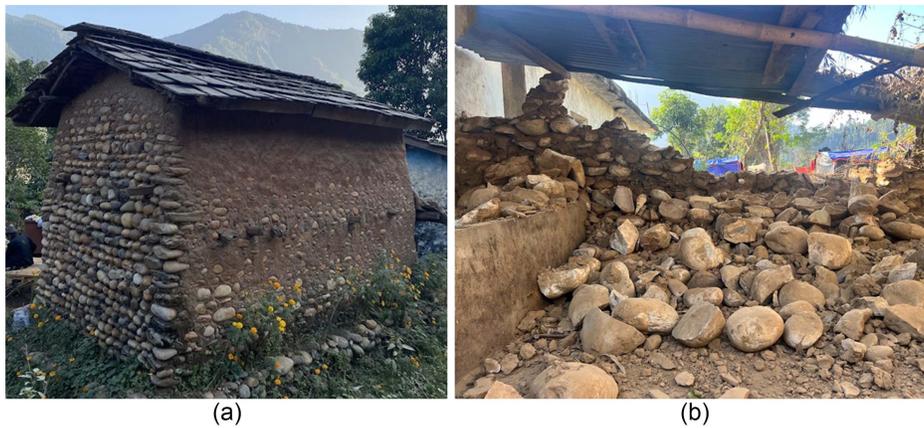
**Fig. 13.** (a) Building made up of highly irregular and rounded stone; and (b) collapse building made up of boulder directly transported from river ( $28^{\circ}41'55''$  N,  $82^{\circ}13'45''$  E). (Images by Rajan KC.)

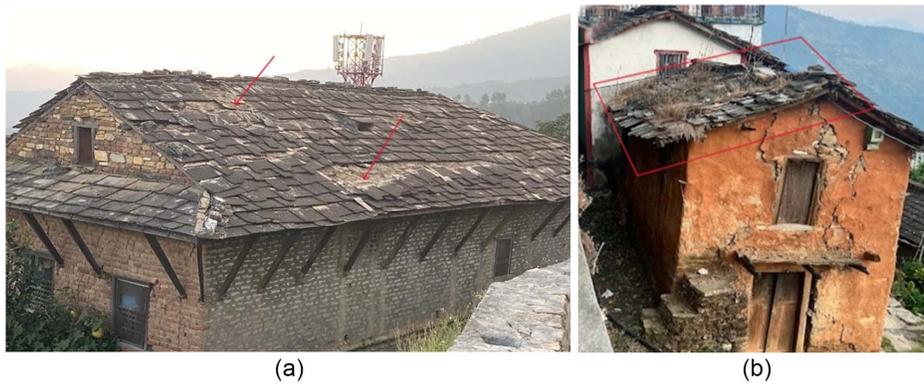
**Heavy Roof.** The roofs of the damaged buildings were typically constructed with a layer of stone spread over wooden planks. The aging of the layer of planks and wooden rafters led to a decrease in their load-bearing capacity, resulting in numerous roof failures during the earthquake (Fig. 14). Roof components built with wooden components having lower strength tend to deflect and sag, leading to water pooling in vulnerable areas. To avoid this, locals often opt to add a new layer of stone on top of an existing roof, thereby further increasing its load and hence increasing the risk of failure. In contrast, neighboring structures with roofs made of corrugated iron or other lighter materials experienced fewer failures.

**Fig. 14.** (a) High degree of weathering of the roof made by stone; and (b) collapse of stone roof resulting from deterioration of wooden support inside ( $28^{\circ}41'56''$  N,  $82^{\circ}12'01''$  E). (Images by Rajan KC.)

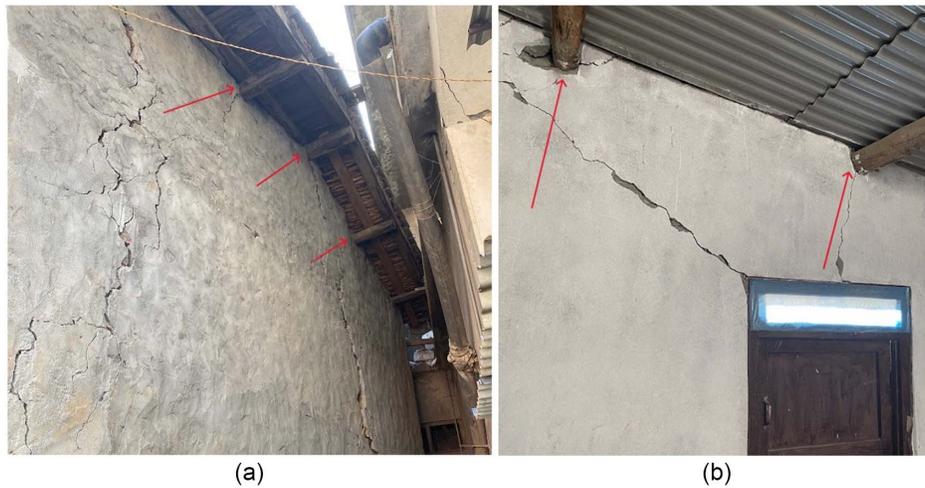
**Poor Connections between Walls and Roofs.** The lack of sufficient connections between walls and roofs was noted as a contributing factor to increased damage. In most buildings, roofs were constructed with stone and timber directly placed on the load-bearing walls as

**Fig. 15.** Roof support resting on masonry directly and propagation of crack ( $28^{\circ}41'55''$  N,  $82^{\circ}16'46''$  E). (Images by Mandip Subedi.)

shown in Fig. 15. As evidenced in the 2005 Kashmir Earthquake, walls supporting an inclined roof undergo lateral thrust in their out-of-plane directions, posing a serious risk of damage to the walls (Oyguc and Oyguc 2017). This scenario remained consistent following the 2023 earthquakes in Jajarkot, Nepal.

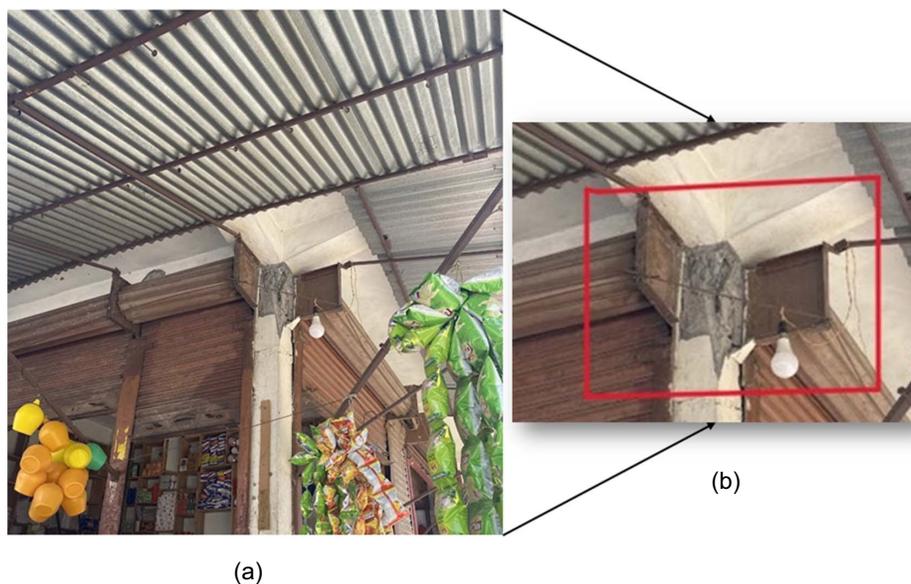
Significant damage was noted in an RC building equipped with rolling shutters, primarily linked to a column failure (Fig. 16 depicts its enlarged view). The installation procedure of rolling shutters requires the removal of the cover of RC columns at specific positions aligned with column. This exposes the primary reinforcement bars, which are then welded to the shutter guide. The incorporation of rolling shutters significantly altered the stiffness and moment capacities of the RC columns by decreasing the column's cross-sectional area and reducing the strength and stiffness of the reinforcement bars resulted from overheating caused by the welding procedures. Similar findings were noted in the aftermath of the 2015 Gorkha Earthquake in Nepal (Sharma et al. 2016), and the Koceali Turkey 1999 earthquake (Sezen et al. 2003).

**Fig. 16.** (a) Destroyed column due to the installation of rolling shutter at Rimna Bazaar, Jajarkot; and (b) enlarged view ( $28^{\circ}41'55''$  N,  $82^{\circ}16'46''$  E). (Images by Rajan KC.)

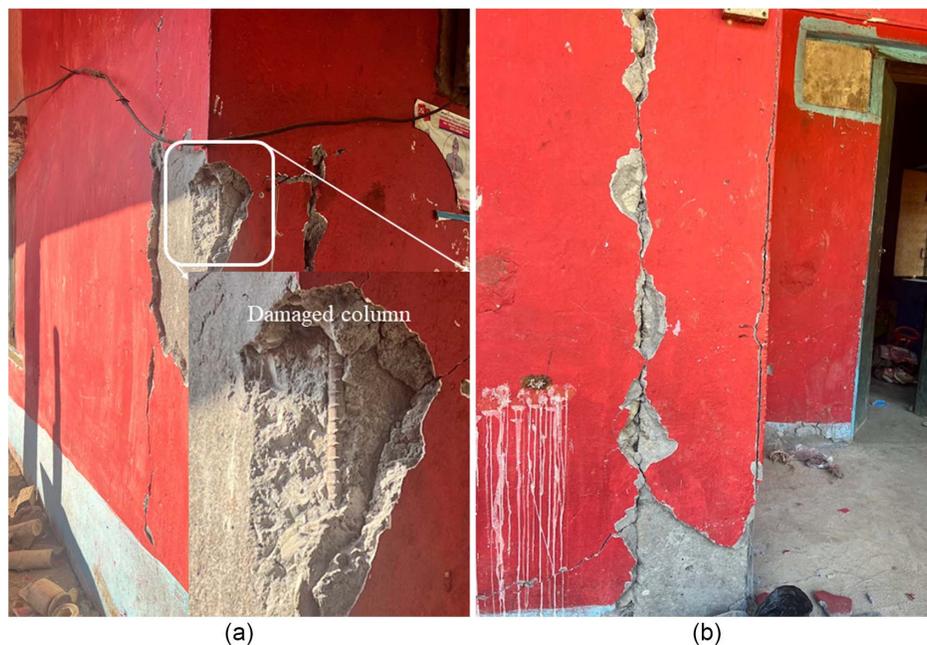
**Fig. 17.** Crushed RC wall and column made up of poor concrete mixture with elongated aggregate (28°41'55" N, 82°13'45" E). (Images by Rajan KC.)

It was evident that inferior concrete quality was used to construct the buildings damaged during the earthquake. Low-strength concrete utilized in RC structures are illustrated in Fig. 17. The concrete in these structures readily crumbled when touched by hand, signifying a notable decrease in its strength. The substantial weakening of concrete materials resulted from the use of large and poorly graded aggregates, resulting in a honeycomb pattern in the cast concrete, further weakening its strength. The spalling of concrete in numerous RC buildings during the Haiti Earthquake of 2010 was attributed to subpar concrete quality and defects in workmanship as well (Rathje et al. 2011; O'Brien et al. 2011).

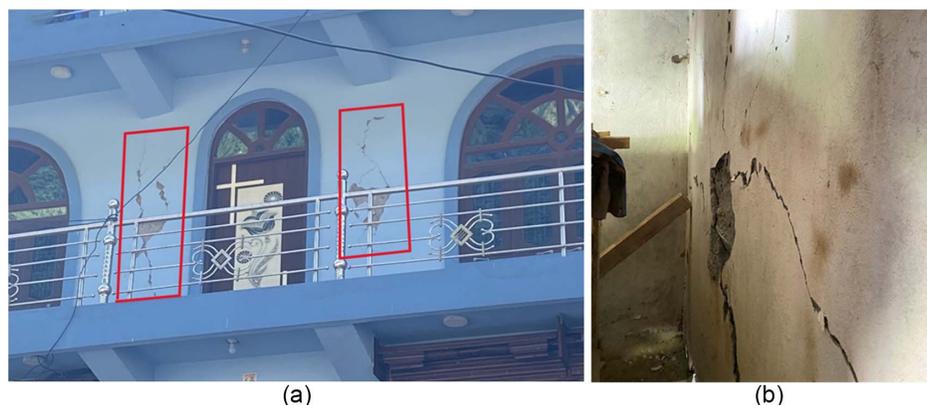
Due to the absence of sufficient connection measures between the infill wall and the beam-column in the frame structure construction, infill walls are prone to detachment at their interface, resulting in a penetration crack, as illustrated in Fig. 18. Infill wall destruction and diagonal shear crack in RC buildings was also a common mode of failure in previous earthquakes like the 2001 Bhuj Earthquake in India (Goel 2001).

**Fig. 18.** Destruction of infill wall of four-story RC house at Rimna Bazaar, Jajarkot (28°41'55" N, 82°16'46" E). (Images by Rajan KC.)

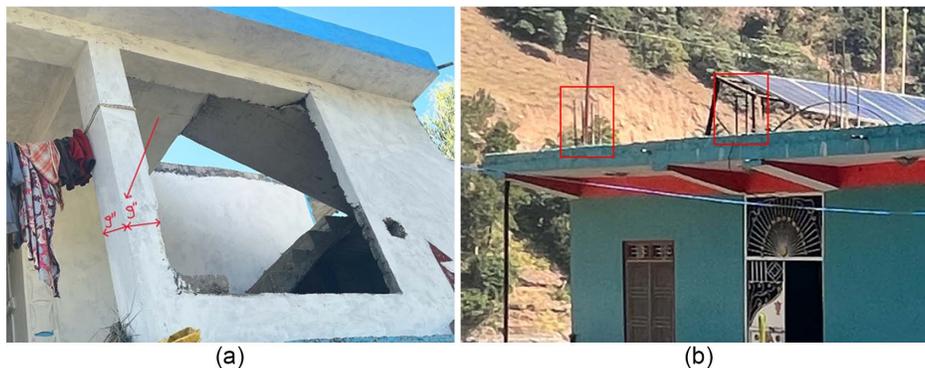
**Fig. 19.** (a) Undersized column; and (b) all rebars cut in the same level (28°41'55" N, 82°13'45" E). (Images by Mandip Subedi.)

Most of the damaged structures in the area were constructed using brittle masonry and poorly designed and constructed reinforced concrete. Numerous houses were constructed by their owners, aided by local masons who are unfamiliar with the Nepal Building Code (NBC) and solely rely on their own construction expertise. As a result, the houses were built without engineering consultation and proper specifications, making them more susceptible to damage. Notably, the column size in these buildings is  $9 \times 9$  in. [Fig. 19(a)], falling below the minimum size recommended by NBC, which is  $12 \times 12$  in. Another concern is the inadequacy of vertical reinforcement. In some cases, columns in two- and three-story buildings contain only four 12 mm diameter rebars, with lateral ties spaced more than 300 mm apart. Additionally, a common practice is joining all rebars at a single joint with a much shorter splice length [Fig. 19(b)].
