Performance Assessment of Buildings Impacted by the 2019 Windstorm in the Central-South of Nepal

Abstract: The 2019 windstorm in Nepal struck villages in the Bara and Parsa districts, central-south of Nepal, on March 31, 2019, causing widespread devastation. The storm, rated five (5) on the Enhanced Fujita Scale, cut a 33 km swath through central-southern Nepal. In total, 1,452 private houses were destroyed, while 1,373 others suffered partial damage. The tragic storm claimed 28 lives and left 1,155 individuals injured. The impact of this tragedy extended to nearly 3,000 families. Immediately after the storm, a comprehensive damage assessment framework was developed, and a field reconnaissance study was conducted to understand the damage distribution and building failure mechanisms under tornado wind loads. Common damage modes observed were roofing material damage, roof-to-wall connection failure, and brittle masonry wall failures in the affected areas. This paper presents the lessons learned from damage to the building infrastructure during the 2019 windstorm in Nepal. Examined buildings underscore the critical need for design alternatives and sustainable retrofits, emphasizing l

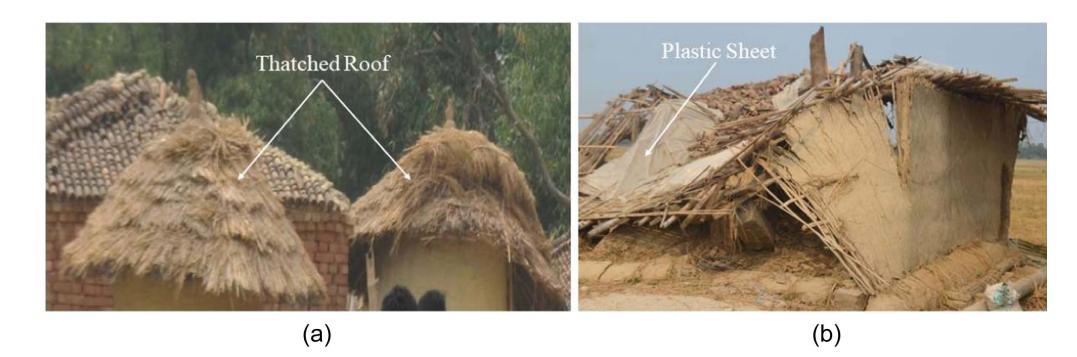
Thatch roof Fig. 6(a) is common in the affected region, providing a cost-effective and locally resourced roofing option for families below the poverty line in Madhesh province. Fig. 6(b) is an adobe structure with a plastic sheet and tile roof. Structurally thatched roof buildings and plastic roof buildings are similar. These roofs are lightweight and do not require a strong truss framework for support. However, they are vulnerable to moderate winds, due to the lack of structural connectivity and weak roof–wall connections, particularly at corners and perimeters, where flow separations and vortex formation result in high suction pressures. Further, thatch wall with

mud plaster without connectivity with the ground level or under the foundation has been completely removed.

Fig. 6. (a) Thatched roof buildings in relatively less wind affected area of Bara; and (b) collapsed plastic sheet roof and lateral support of bamboo. (Images by Apil KC.)

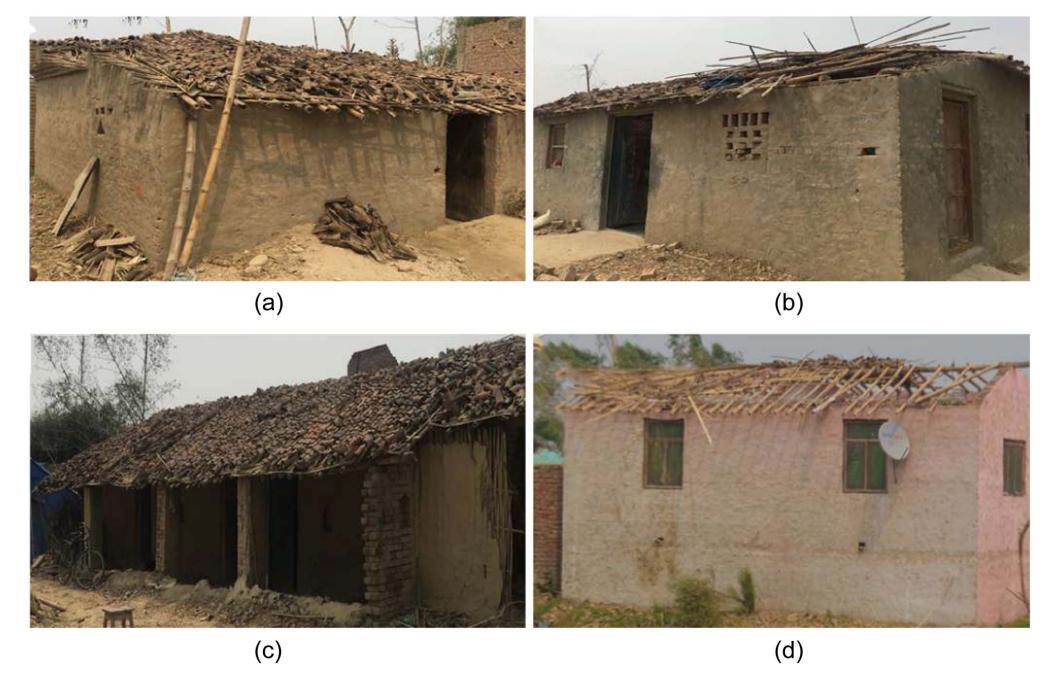
The damage to tiled roof masonry (Fig. 7) during a storm resulted from a combination of factors, including aging of the roof support structure, intense storm suction pressures, and inadequate tile nailing to the purlin. Poor connection between roofing materials is also why this type of failure occurred. Over time, the support system weakens, making the roof susceptible to external forces. Even a well-tied roof system can be destroyed in an EF5-scale storm. Suction pressures, especially at vulnerable points with decayed tiles, worsen structural vulnerabilities, leading to roof destruction and overall masonry collapse. This highlights the need for regular maintenance and reinforcement of roof support structures to improve resilience against adverse weather conditions.

Fig. 7. Damaged tiled roof with no severe damage on the wall. (Images by Apil KC.)

- The resistance of roofing systems should be improved by providing concrete restraining strips over tile cladding roofs at suitable intervals, anchored to main rafters, to resist uplift forces better and prevent damage to roofing materials during windstorms.

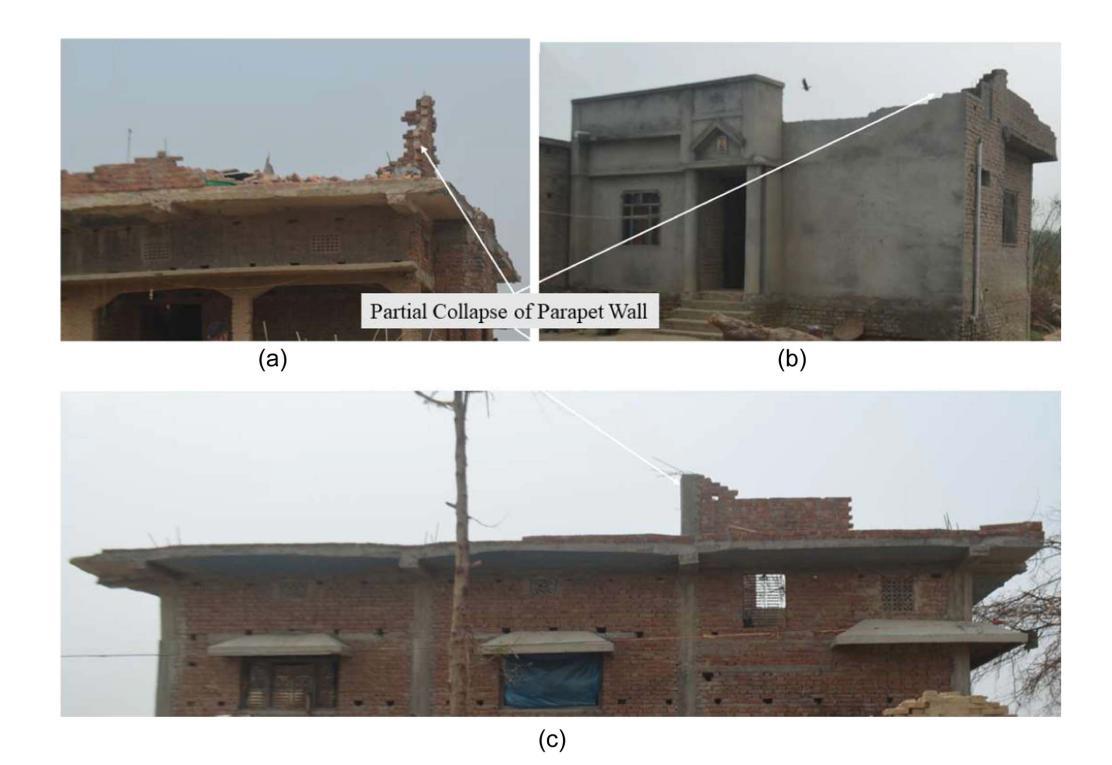
Limited damage to RC buildings primarily resulted from substandard construction. RC buildings with brick masonry and isolated structures have fallen. There is a weak connection among structural elements such as slab, walls, and terrace parapet walls. The main issue observed was damage on the parapet wall (Fig. 8), often lacking proper anchorage with the roof when damaged. In most of the RC buildings that lie in wind paths, some parts of buildings are damaged, but structural failure is not common. Another issue observed on RC buildings in wind-affected areas was the out-ofplane collapse of infill walls, particularly brick walls blown away in the out-of-plane direction. Their lack of connection to the main

Fig. 8. Partial damages on parapet wall of RC buildings. (Images by Apil KC.)

structural system made them prone to out-of-plane failure under lateral forces.

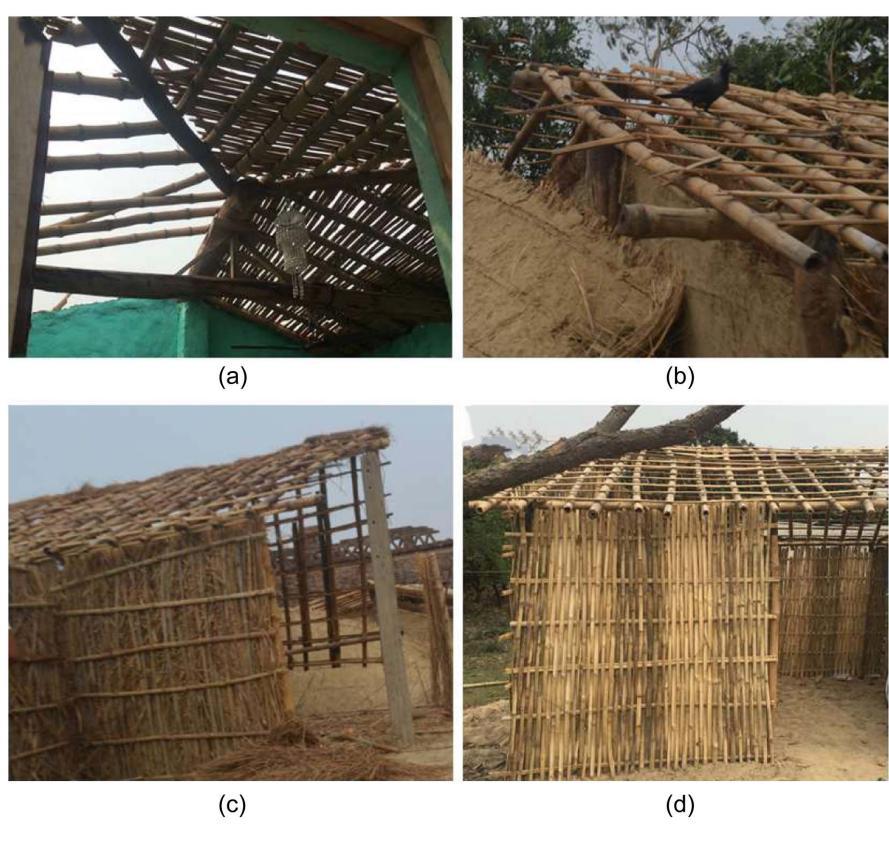
Fig. 9. Round-shaped purlin with poor connection vulnerable to wind. (Images by Apil KC.)

common failures included slipping off from tie beams and breakage. However, these support strings lack proper design to resist windstorms and are not adequately tightened on tie beams or trusses. Round-shaped members make them more vulnerable to wind forces as their connection is not sufficient. There are no design standards or rules for providing support strings to traditional Nepalese roofs. Most commonly observed ones are irregular circular timber purlins, and rafters at the roof ridge have insufficient connections, typically simple lap joints with a single toenail, which, coupled with the irregularity of circular timber, weakens the structure, especially during strong winds (Fig. 9).

- Suitable roof bracing should be provided and anchorage, bracing, and continuity in building design ensured to optimize structural integrity and increase resistance to wind forces, thus minimizing the risk of structural failure and enhancing overall safety.

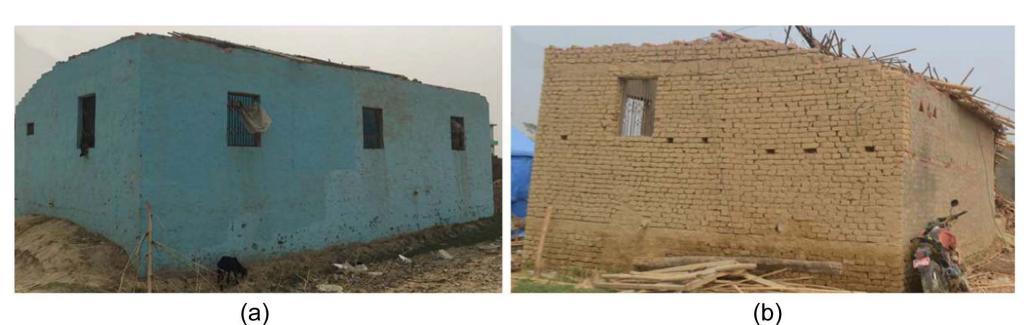
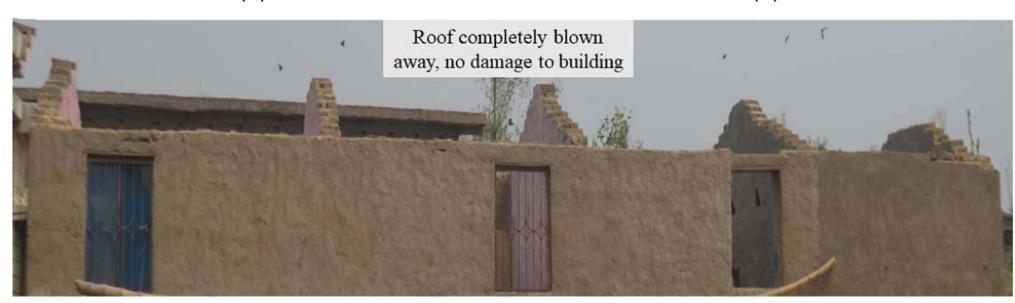
The most common failure in wind-affected areas is the complete blowing away of roofs (Fig. 10). In some buildings, the roof is

Fig. 10. Complete blown away of roof without much damage on wall. (Images by Apil KC.)

entirely displaced, with minimal damage to the walls and other structural elements. This is primarily attributed to poor connections between the wall and the roof. In many instances, the roof is directly supported by a brick wall at one end and tied to the roof ridge at the other. No straps or plates are employed to link the rafters to the rooftree beams for wind pressure resistance. The connections at the roof ridges are insufficient to endure the force of a windstorm. Typical houses of urban settlements have roof connections at three points: one at the front side supported by vertical struts and two on load-bearing walls, all supported. Despite relying solely on selfweight to resist uplift wind pressure, the lack of rigid connections between walls and roof members renders them vulnerable.

- Building frames and masonry walls must be designed not only to resist vertically acting dead and live loads but also to have sufficient lateral strength to withstand wind forces. Support columns or posts must be safely anchored to the roof and foundation.

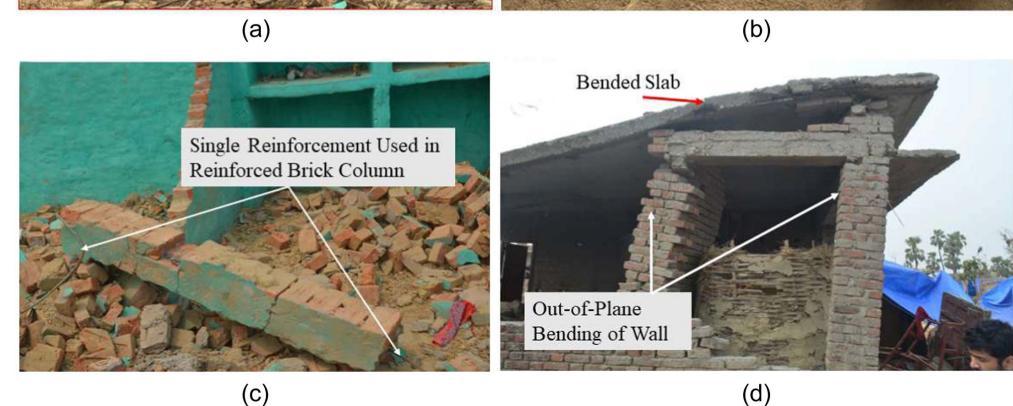
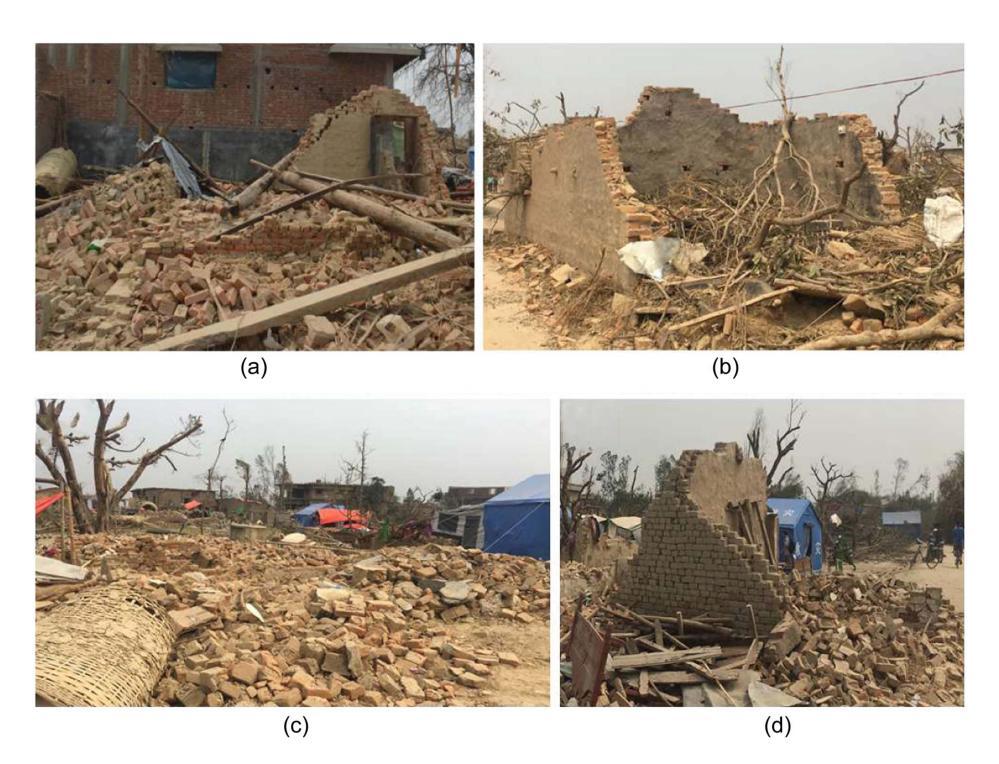
In the central-south windstorm of 2019, numerous buildings experienced substantial damage, with some structures collapsing entirely. Fig 12(a) illustrates a mud mortar brick masonry example of brittle failure, where the structure completely collapsed. In Fig. 12(b), half of the wall collapsed entirely, while the other half remained standing, indicating a potential out-of-plane failure. Fig. 12(c) showcases another instance of brittle brick masonry failure, and, in Fig. 12(d), a building collapsed, leaving only the partition wall standing. The complete collapse of masonry residential buildings was also prominent in a strong windstorm on June 16, 2018, in northern Nigeria (Kafi et al. 2021). Construction and maintenance shortcomings have been recognized as the predominant root causes of most frequently occurring infrastructure collapse during windstorm (Wardhana and Hadipriono 2003).

Fig. 12. (a) Brittle failure of brick masonry; (b) half failure of brick masonry; (c) mud mortar brick masonry failure; and (d) collapse of brick masonry with partial partition wall. (Images by Apil KC.)

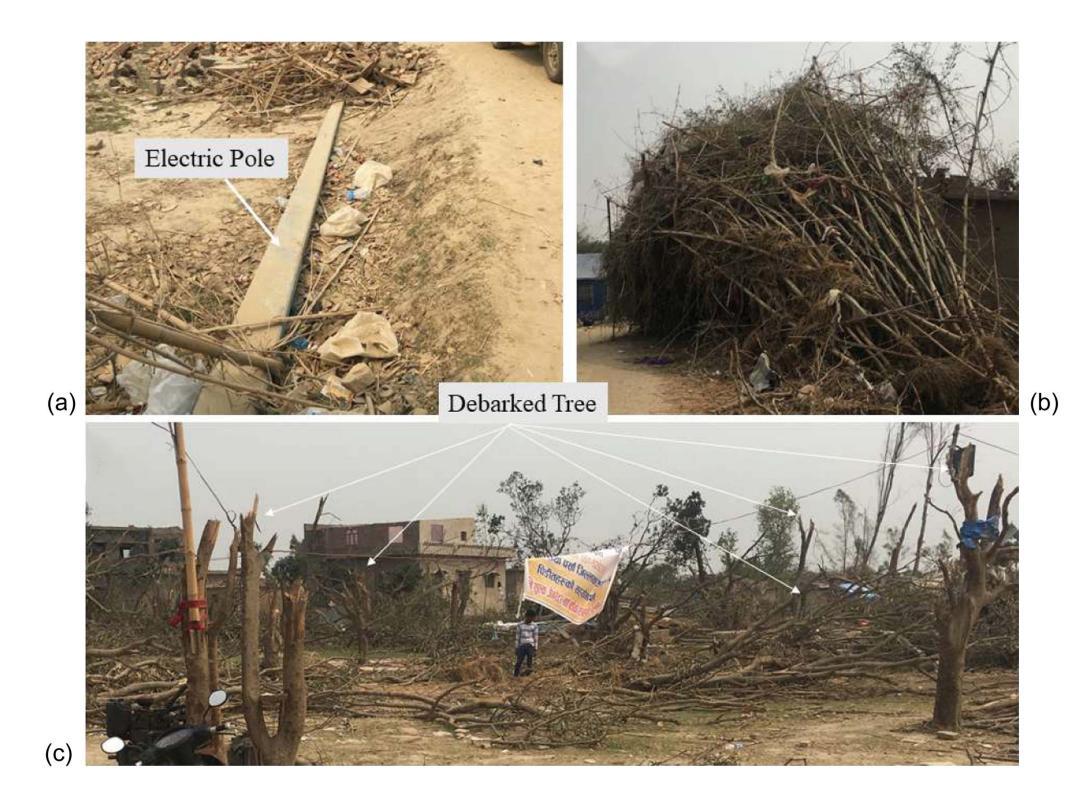
Numerous utility poles supporting electricity lines collapsed [Fig. 13(a)], potentially due to inadequate lateral support and strong wind currents. Additionally, a bamboo thicket within the area affected by the wind sustained damage [Fig. 13(b)]. Several trees lost branches, and some were uprooted as well [Fig. 13(c)]. In addition, the network of lines in many partially damaged houses has experienced short circuits, and the supply chain for drinking water is also disrupted.

Fig. 13. (a) Fallen electric pole during wind; (b) damaged bamboo thicket; and (c) some debarked tree. (Images by Apil KC.)
