# Seismic Performance of Buildings during the November 2023 Earthquake in Jajarkot, Nepal

Rajan KC<sup>1</sup>; Kabin Lamichhane, Aff.M.ASCE<sup>2</sup>; Keshab Sharma<sup>3</sup>; Mandip Subedi<sup>4</sup>; and Shikshita Bhandari<sup>5</sup>

**Author keywords:** 2023 Nepal Earthquake; Jajarkot Earthquake; Field reconnaissance; Structural damages; Masonry buildings; Reinforced concrete buildings.

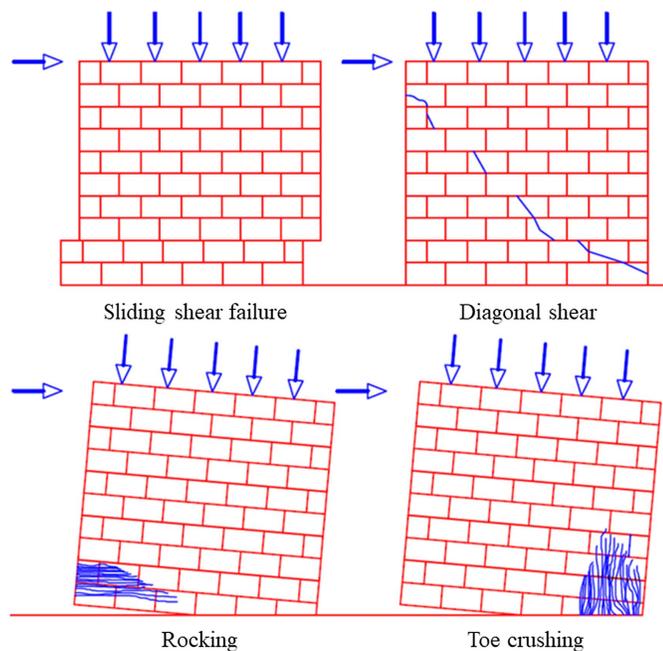
buildings. Fig. 8 shows the common types of failure patterns in masonry structures subjected to in-plane loads.

**Fig. 8.** Illustration showing common failure patterns of masonry walls subjected to in-plane shear.
