Performance Assessment of Buildings Impacted by the 2019 Windstorm in the Central-South of Nepal

Abstract: The 2019 windstorm in Nepal struck villages in the Bara and Parsa districts, central-south of Nepal, on March 31, 2019, causing widespread devastation. The storm, rated five (5) on the Enhanced Fujita Scale, cut a 33 km swath through central-southern Nepal. In total, 1,452 private houses were destroyed, while 1,373 others suffered partial damage. The tragic storm claimed 28 lives and left 1,155 individuals injured. The impact of this tragedy extended to nearly 3,000 families. Immediately after the storm, a comprehensive damage assessment framework was developed, and a field reconnaissance study was conducted to understand the damage distribution and building failure mechanisms under tornado wind loads. Common damage modes observed were roofing material damage, roof-to-wall connection failure, and brittle masonry wall failures in the affected areas. This paper presents the lessons learned from damage to the building infrastructure during the 2019 windstorm in Nepal. Examined buildings underscore the critical need for design alternatives and sustainable retrofits, emphasizing l

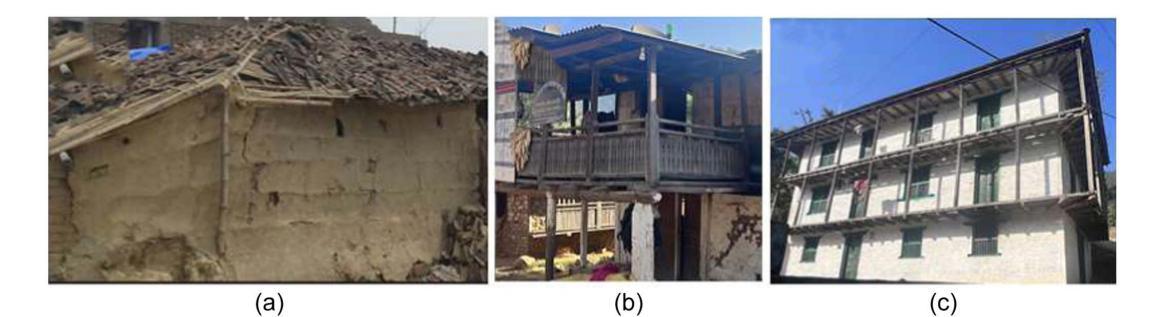
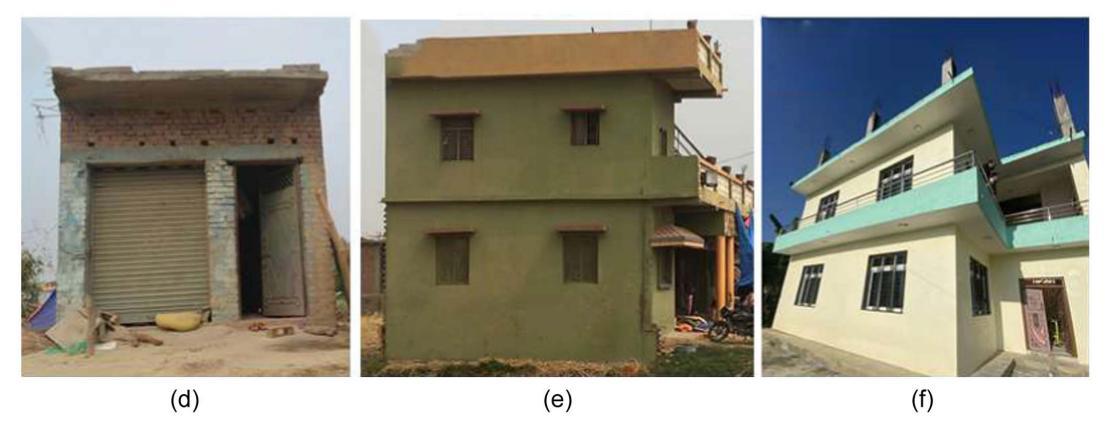
Fig. 2. Existing building types in Nepal: (a) adobe; (b) wooden; (c) brick with mud mortar; (d) brick with cement mortar; (e) nonengineered RC; and (f) engineered RC. (Images by Rajan KC.)

Building type	Description	Figure reference
Adobe	Constructed from a mixture of mud, water, cow dung, and organic materials, with or without a wooden frame; these materials typically have a wall thickness ranging from 200 to 350 mm and lack any reinforcement. Such structures are highly susceptible to both wind and earthquakes.	Fig. 2(a)
Wooden	Built with wooden posts sourced from tree trunks and walls constructed from wooden planks or woven bamboo with mud plastering; bamboo posts are inserted into the ground up to approximately 1 m. The walls lack reinforcement, making the structure susceptible to wind, earthquakes, and fire.	Fig. 2(b)
Brick in mud mortar	Unreinforced brick masonry in mud mortar, without confinement, featuring wood or masonry lintels and wood-framed floors supporting substantial mud floor and roof slabs, with half brick wall thickness of around 110 mm, is particularly susceptible to both wind and earthquakes.	Fig. 2(c)

Brick in cement mortar	Residential buildings of low height, constructed with burnt bricks using cement mortar, may or may not include light reinforcement. The outer wall has a thickness of 230 mm, while the inner wall is 115 mm thick, rendering them susceptible to both wind and earthquakes.	Fig. 2(d)
Non-engineered RC	Reinforced concrete frames with brick infills, lacking structural design compliance with building codes. The structure features cast-in-place concrete beams and columns, along with cast-in-place concrete slabs for floors and/or roof. The inadequacy in providing sufficient wind load and seismic resistance makes the structure vulnerable.	Fig. 2(e)
Engineered RC	Reinforced concrete frames with brick infills, incorporating cast-in-place concrete beams and columns along with concrete slabs, typically adhere to Nepal building codes and Indian standard codes for seismic design. Special detailing is implemented to ensure ductile performance, rendering the structure relatively safe.	Fig. 2(f)

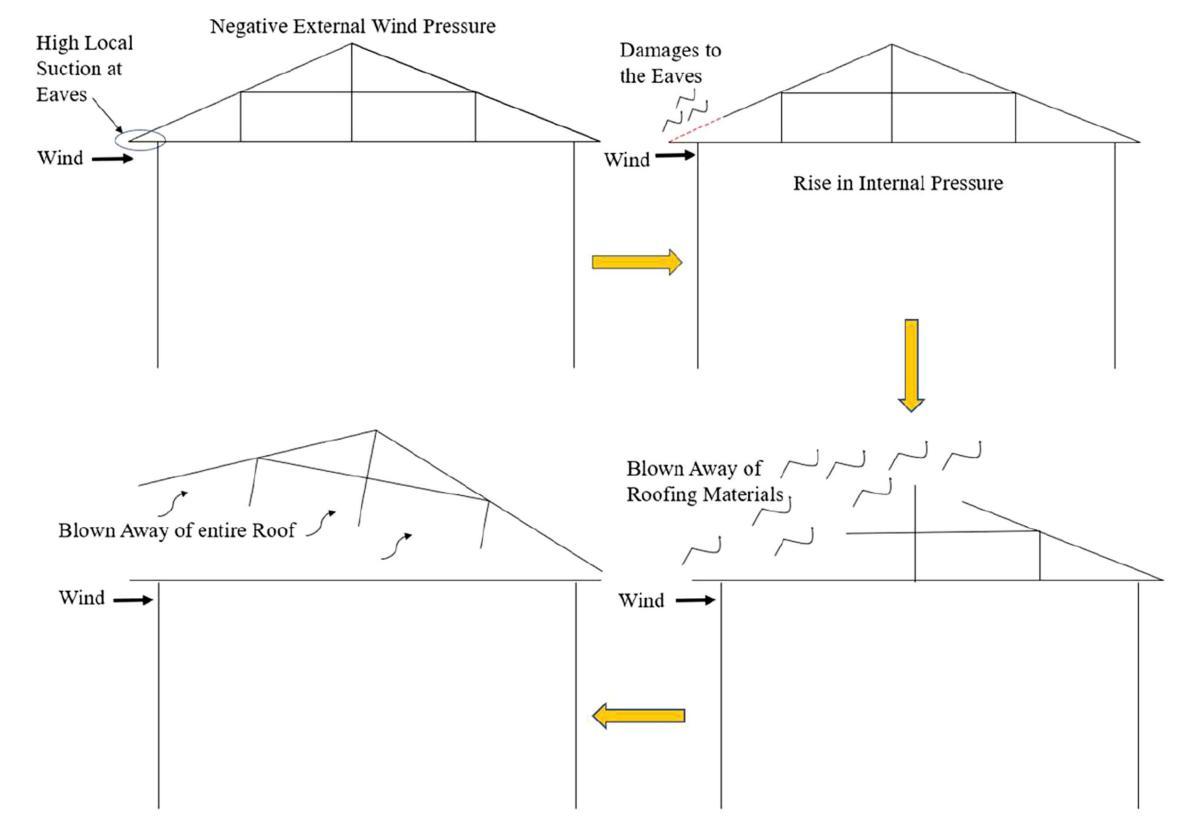
Roof damage in a windstorm follows a sequential process, as illustrated in Fig. 5. The windstorm initiated a strong suction in the eaves, the overhanging part of the roof. Simultaneously, there is a significant negative wind pressure on the outward sides of the roof. This combination triggered the initiation of roof damage through the eaves. Subsequently, the wind enters the interior of the building, causing an uplift of the roof by increasing the pressure inside. The heightened wind pressure damaged the entire roofing material, and, depending on the force of the wind, it can ultimately lead to the overturning of the roof. Roof failure is one of the common types of failures during windstorms (Mahendran 1995; Sill and Kozlowski 1997). During Hurricane Harvey in 2017, damage to roof components was reported as the most common type of damage in the Port Aransas Region (Aghababaei et al. 2018).

Fig. 5. Roof damage chain during a windstorm. [Reprinted from *Journal of Wind Engineering and Industrial Aerodynamics*, Vol. 44 (1–3), Y. Uematsu, M. Yamada, H. Higashiyama, and T. Orimo, "Effects of the corner shape of high-rise buildings on the pedestrian-level wind environment with consideration for mean and fluctuating wind speed," pp. 2289–2300, © 1992, with permission from Elsevier.]
